# Suitability Analysis of Office Building Design against Maintenance Cost (Case Study of Serayu Opak River Basin Organization, Yogyakarta Province)

This study aims to determine the effect of building design's inaccuracy against the cost of maintenance, by taking the research in Serayu Opak River Basin Organization, Water Resources Field and Water Resources Management Center in Yogyakarta Special Region. The first step is to analyze the inaccuracy of building design based on the result of interview and observation during field survey. The second step is to analyze the cost of building maintenance. The third step is to analyze the maintenance costs used to minimize the effects of the inaccurate design of the building. The result shows the inaccuracy of building design in the form of the use of clear glass without coated glass film and the absence of heat insulator on the roof of the building cause the room to become hot. The installation of rain gutters without vertical pipes, toilet facilities in the entire building is not yet complete, inadequate accessibility for persons with disabilities, and inadequate corridor design. There is a small portion of the maintenance budget used for

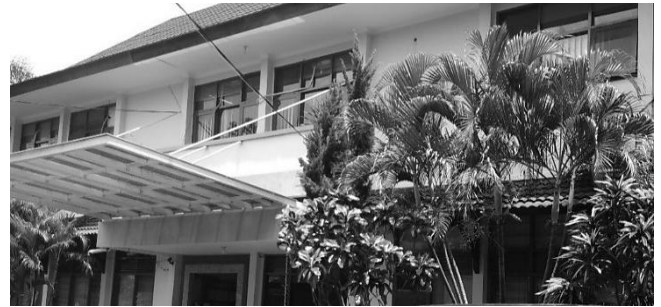
Buildings that became the object of research using a lot of clear glass as a cover of the building so that the rooms are exposed to the sun's heat during the afternoon, so the room becomes hot and glare. The hot and glare room is not suitable for the comfort requirements of the building contained in Government Regulation No. 36/2005 on the Implementation of Law Number 28 Year 2002 regarding Building. Image of the exposed part of the building can be seen in Figure 1.

Figure 1. The side of the Serayu Opak River Basin Organization building.

The glass used in the building is clear glass 3 mm. Clear glass has the nature of continuing 90% of visible waves and 85% of the sun's radiation into the room thus making the room become glare and room temperature increases (Soegijanto, 1998). To reduce the heat and the glare in the room, the best solution that can be done is to install window film. In order not to reduce the aesthetics should use a clear window film with a large TSER value on building glass (Astuti, 2017).

- a) Renovate the roof and side of the building by installing a heat insulator on the roof and coated glass with clear film glass.
- b) Replace/redesign the gutter by adding a vertical pipe to the outlet pipe (funnel) to allow rainwater to enter fully into the drain.
- c) Equip toilets with facilities in accordance with Indonesian Public Toilet Standards.
- d) Increase access for people with disabilities.
- e) Install the alarm for emergency situations so that the evacuation process can be done earlier and faster.
- f) Make clear signs and parking limits.

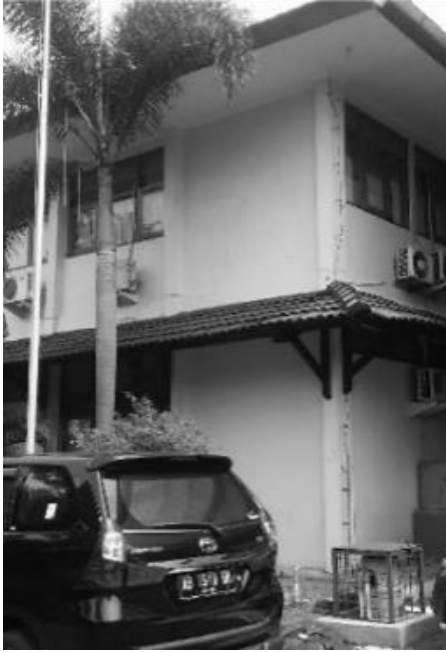
In Figure 2, we can see the design of less suitable gutters because the outlet pipe (funnel) is located at an altitude of  $\pm 7$  m from the soil surface so that the rain flow from the roof will fall inappropriately in the rain drain. It should be on the gutters mounted vertical pipe to approach the sewer so that rainwater from the roof can be entirely wasted into the sewer.

Figure 2. Rainwater gutters without vertical pipes at Serayu Opak River Basin Organization building.

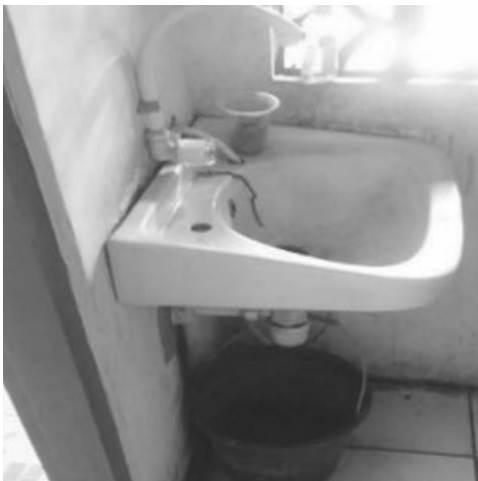
The sink position in Water Resource Management Centre (WRMC) building is not in accordance with Indonesian Public Toilet Standards (Figure 3) because it is installed in the corner and too close to the wall making it difficult for users to wash their hands and or faces.

Figure 3. The location of the sink in the Water Resources Management Centre (WRMC) building.

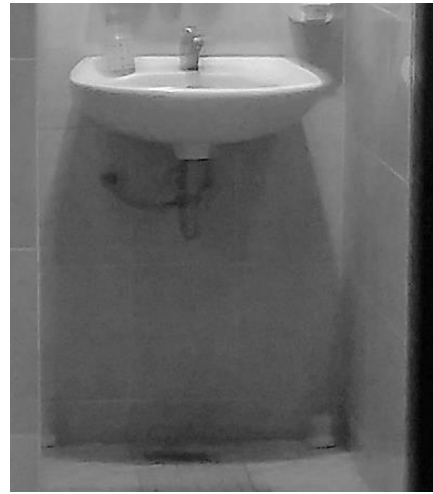
The width of the sink room in the toilet room of the Serayu Opak River Basin Organization which is only 75 cm in size is not suitable for the recommended size in Indonesian Standard Public Toilet by 90 cm. The

Figure 4. The sink room in the toilet of the Serayu Opak River Basin Organization building.

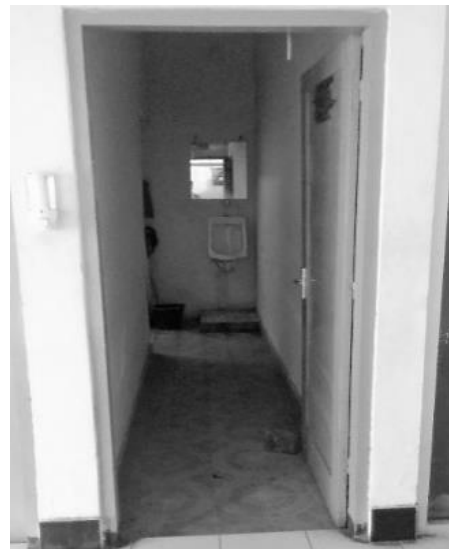
The location of the urinal at the end of the toilet and facing directly into the corridor is less unsightly, especially when there are employees who use it to urinate (Figure 5).

Figure 5. Location of the urinal in PJSA and Water Resources Field (WRF) building facing corridor.

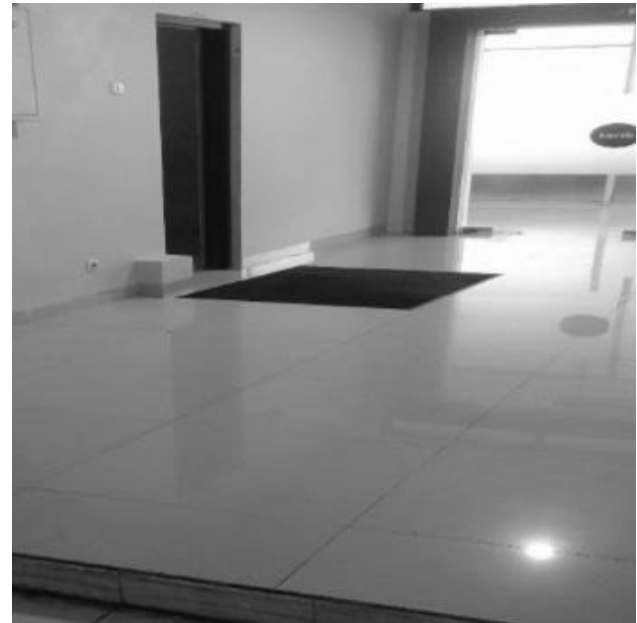
- a) The absence of guiding block and Braille facilities around the building can reduce accessibility for the visually impaired.
- b) There is a step on the access to the entrance and toilets. This makes it difficult for wheelchair users to enter the building without assistance as seen in Figure 6 and Figure 7. It should be at the entrance of the building made ram so that wheelchair users can enter the building with ease.
- c) There is a parking lot of vehicles blocking access to the entrance. This is due to the absence of signs, parking borders, and information boards so that workers park vehicles freely as seen in Figure 8.

Figure 7. The steps at the entrance of Serayu Opak River Basin Organization (SORBO) toilet.

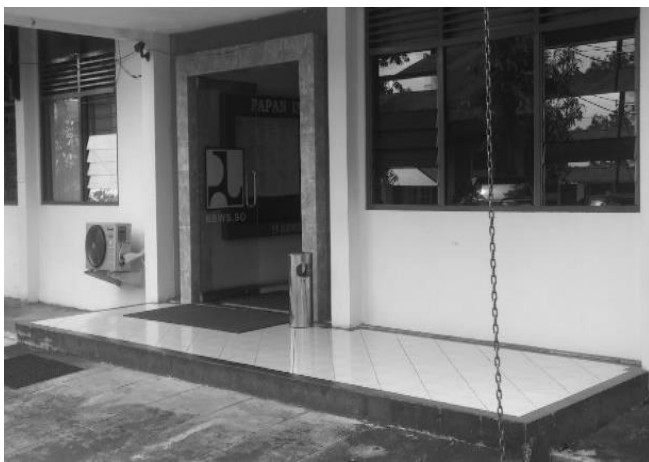
Figure 6. The steps at the entrance of Serayu Opak River Basin Organization (SORBO) building.

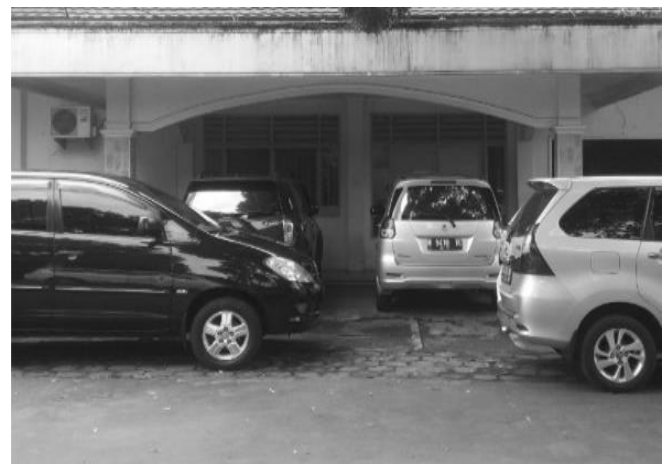
Figure 8. Access to the entrance of PKSDA building blocked by vehicles.

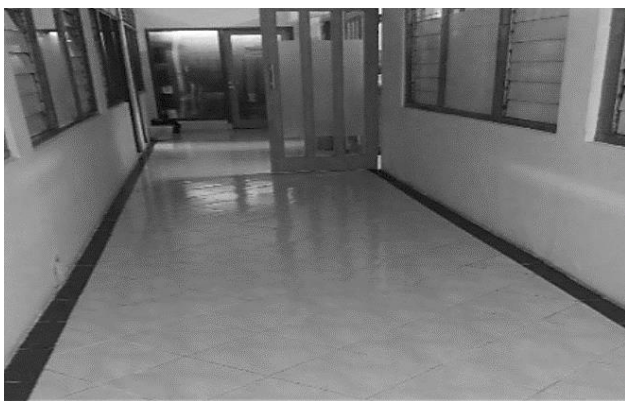
The corridor of Serayu Opak River Basin Organization (SORBO) building area has only 1.7 m width (Figure 9). Not in accordance with the Regulation of the Minister of Public Works No. 45 / PRT / M / 2007 Year 2007 on Technical Guidelines Development of the State House which requires a minimum width of 1.8 m net corridor.

Figure 9. The corridor of Serayu Opak River Basin Organization (SORBO) building.

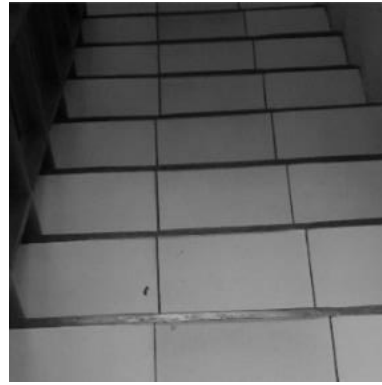
Residential building/building consisting of 2 floors or more, the size of the stairs used has a minimum width of 125 cm. However, the staircase in the Water Resources Management Office building is only 85 cm wide as can be seen in Figure 10.

Figure 10. Stair in Water Resources Management Building.
