New Alignment Method Using Hydraulic Jack for Accelerating SWD 16 TM 410 R Engine and Generator Coupling¹

S.D. Nugroho* and Fajriannur

ULPLTD/G Trisakti, PT. PLN Indonesia Power UPDK Barito Indonesia *E-mail: satriyo.nugroho@plnindonesiapower.co.id

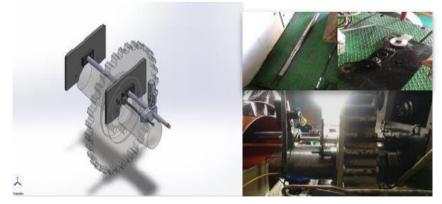
Figure 6. Line Boring Tool for Reaming

In the current stage of our project, we are faced with reaming the remaining eight holes. Using traditional methods, this task would consume a significant amount of time, approximately 40 days. Recognizing the need for a more efficient approach, we opted to innovate and design a specialized tool. This tool, presented in Figure 6, adapts a line boring tool customized to suit our reaming requirements. The implementation of this tool remarkably streamlined our operations, reducing the duration of the reaming process to a mere six days. Additionally, the manpower required was notably diminished, with only a team of 2 individuals operating this specialized tool.

Implementing a hydraulic jack in the alignment process significantly expedited the process, showcasing successful alignment within a reduced timeframe. Moreover, employing line boring for the shaft reaming process proved notably efficient, requiring a mere six days to ream eight holes. Consequently, the work process duration has been significantly reduced, notably minimizing the timeline from an initial 54 days to a remarkable 10 days. This equates to an impressive 81% reduction in the overall time required for the task.
