**Evaluation on Fallen Trees of *Hesperocyparis guadalupensis* (S. Watson) Bartel and *Pavetta* sp. in Bali Botanic Garden Based on Visual Assessment and Acoustic Tomography**

Komang Kartika Indi Swari<sup>1</sup>, Dewa Ayu Intan Tirta Sari<sup>1</sup>, Siti Fatimah Hanum<sup>2\*</sup>, Ayyu Rahayu<sup>2</sup>

DOI: 10.22146/jik.v16i1.2173

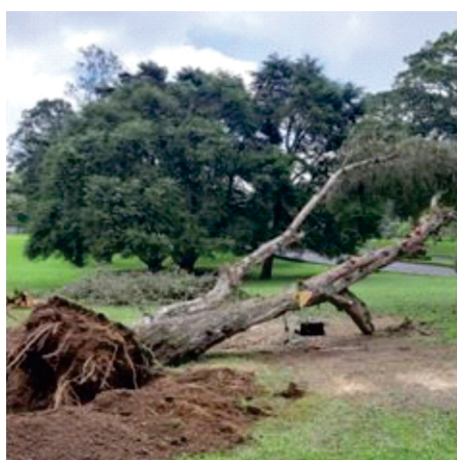
The results of visual assessment showed that *H. guadalupensis* with 12 m tall and a DBH of 70.5 cm had codominant branches (forking branches), branch covered by moss and epiphytes, and trunk condition seemed in good condition (Figure 1a). There were no visible signs of damage to those two fork branching. There were no indication of a stressed physical condition of the tree, except of tree canopy looked asymmetrical. It seemed there was in root problem since it was seen that the roots did not have primary roots with a depth of up to 180 cm (Figure 1a).

**Figure 1.** Fallen tree condition of *Hesperocyparis guadalupensis* (a) and *Pavetta* sp. (b).  
**Gambar 1.** Kondisi pohon *Hesperocyparis guadalupensis* (a) dan *Pavetta* sp. (b) yang tumbang

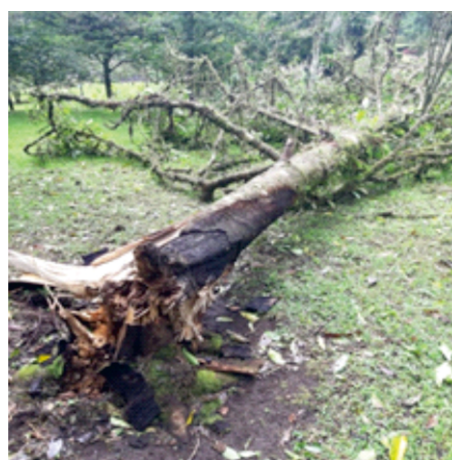
(b)

Another tree of *Pavetta* sp. species had a tree height of 21 m with a DBH of 58 cm. There was a normal tree branching type with a branch covered by mosses and epiphytes (Figure 1b). The surface of the bark, especially at the base, possessed many holes with diameter about below than 1 cm (Figure 2a) that were presumably as the entry points for insects. There were

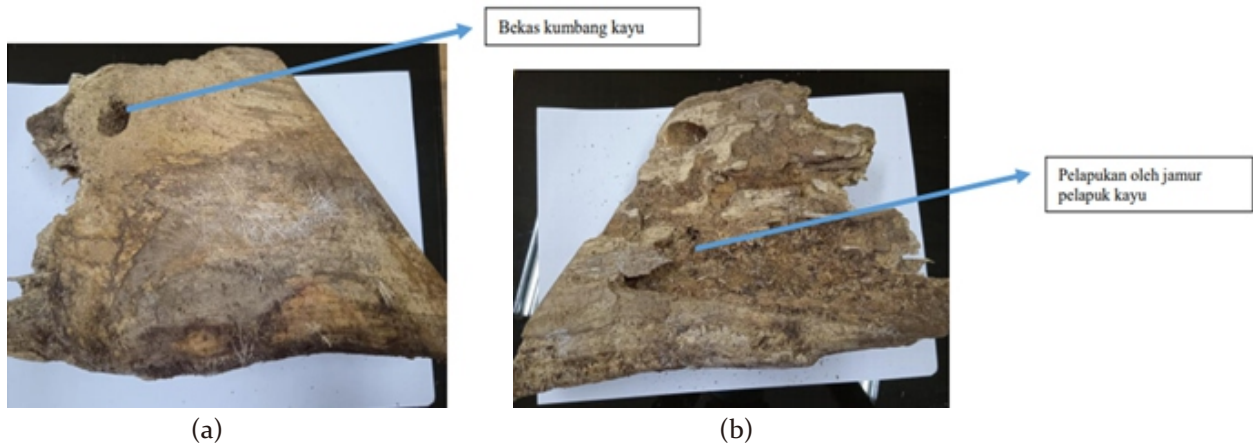
no borer insects on the logs when the inspection, but it seemed any traces decayed. The overall health of the tree (vigor) is low and the leaves underwent chlorosis. Damage to the leaves can occur due to local or systemic symptoms expressed by plants due to pests and diseases (Tsani & Safe'i 2017).

A hollow at the base of the trunk was found around the root collar in *Pavetta* sp. fallen tree. The hollow trunk was presumably caused by the insect borer which commonly attacks the trunks of Rubiaceae trees, namely *Xylosandrus* spp. These insects attacked weathered tree trunks and burrow trunks close to the soil surface (Egonyu et al. 2017). The sample examination results of *Pavetta* sp. which was sent to the Cibinong Advanced Characterization Laboratory - LIPI Integrated Bioproducts Laboratory and found traces of wood beetles (Figure 2a). Besides that, wood rot fungi were also found in the sample (Figure 2b). Decayed wood is very likely to occur at the base of the stem of *Pavetta* sp. due to the humid location of the botanical gardens which has wet condition. Eka Karya Bali Botanical Garden has temperatures ranging from 18-20°C and humidity of 70-90% (Darma et al. 2021). This condition is similar to the Cibodas Botanical Gardens so it has the potential to be a driver of fungal growth that can cause

**Figure 2.** Wood sample with hole as a beetle bite marks (a), wood sample with decayed condition (b) in *Pavetta* sp.  
**Gambar 2.** Sampel kayu yang memperlihatkan adanya bekas lubang gigitan kumbang kayu (a), ampel kayu dengan bekas pelapukan (b) pada *Pavetta* sp.

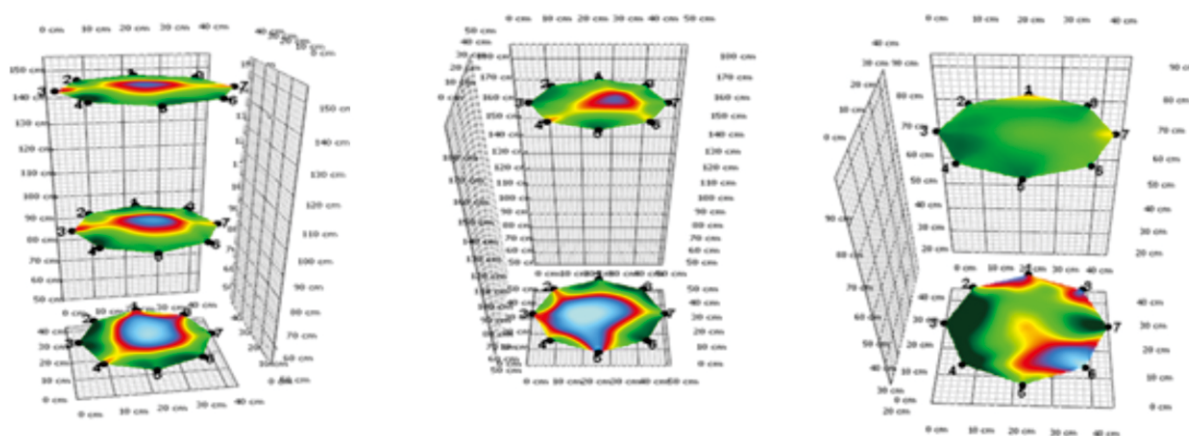
trunk. Therefore, it needs to be supported by internal examination tool such as using Arborsonic 3D acoustic tomograph. The internal examination results showed the blue color region in tomogram result that indicated hollow in the two stems of *H. guadalupensis*. The appearance in outside part showed tree in good visual condition. This result points out the importance to look internal condition when there is a doubt on the internal condition as our tree inspected of *H. guadalupensis*. In visual inspection, the base part of the trunk seemed to look good (Figure 1a.), but further inspection using Arborsonic showed indication holes appear (Figure 3a and 3b.) as represented in blue color in the section of layer 1 and 2 at 50 cm and 150 cm, respectively. After the one of the branches was cut, it can be seen that the inside of the

**Figure 3.** Tomogram first branch *H. guadalupensis* (a), second branch *H. guadalupensis* (b), *Pavetta* sp. (c).**Gambar 3.** Tomogram cabang pertama *H. guadalupensis* (a), cabang kedua *H. guadalupensis* (b), *Pavetta* sp. ©.

tree trunk has no holes but found the rot condition. This difference in results might be due to differences in the selection of species from the Arborsonic software, even though the selection of species has been based on the same of wood density tree species. The stem damage of *H. guadalupensis* was greatest in the rootstock and less in the scion of the tree. Meanwhile, the internal inspection results of *Pavetta* sp. showed a hole at the base of the stem (Figure 3c). After the tree was cut, it can be seen that the inside of the trunk has a hole in the base of the trunk. Based on the category of Helmanto et al. (2018), the category of damage to *H. guadalupensis* was high, while *Pavetta* sp. was classified as moderate (Table 3).

The cause of the fallen *Hesperocyparis guadalupensis* tree is probably contributed by an asymmetrical canopy, shallow roots, windy and wind exposure. Matheny & Clark (2009) reported that most tree failures occur when it is windy. *H. guadalupensis* has an asymmetrical canopy that affects the stability of the tree when receiving partial wind exposure

because the tree is not protected by tall trees around it, thus making the tree easy to fall. The shape of the roots also affects the risk of falling trees. Trees with taproots have a lower risk of falling than fibrous roots (Suripto & Aksari 2020). *H. guadalupensis* does not have a taproot so it has a higher risk of falling. Meanwhile, the cause of the collapse of *Pavetta* sp. was presumably due to weathering at the base of the stem. Upright trees with rotting wood inside are often the cause of tree failure (Goh et al. 2018).

internally, especially at the base of the tree, must be given good treatment immediately to prevent the risk of falling trees. The greatest damage to the lower part of the trunk causes the tree to be more easily damaged and fall (Tsani & Safe'i 2017)
