SITE INVESTIGATION FOR CONSTRUCTION OF EMERGENCY SPILLWAY AT THE JATIGEDE DAM

Abstract

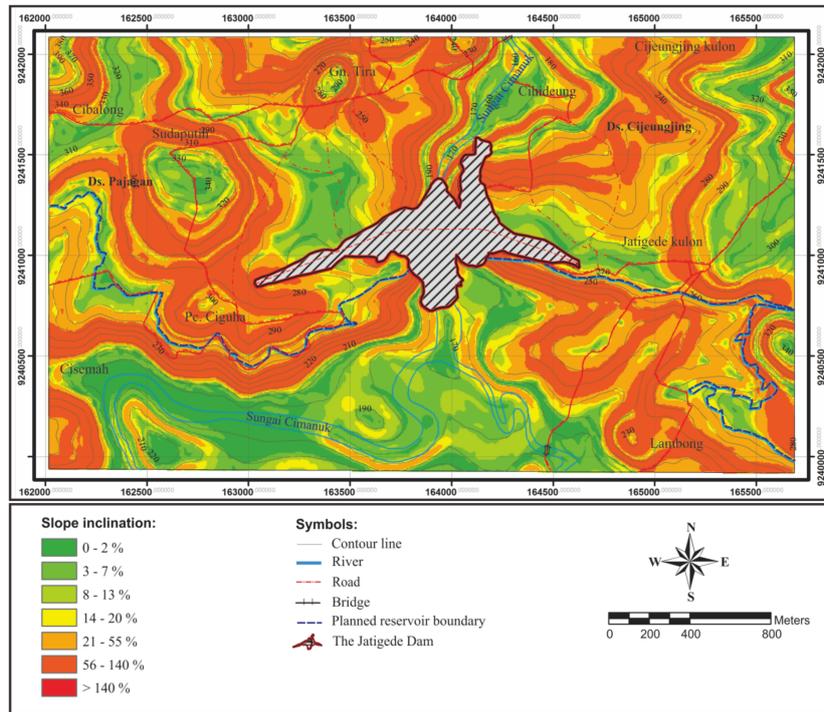
Figure 1: Slope inclination map of the research area.

The area surrounding the Jatigede Dam is characterized by hilly, slope, and river valley morphologies with slope inclination ranging from 0 to 140%. Figure 1 shows the map of slope inclination in the research area that was classified following van Zuidam and van Zuidam-Cancelado (1979). The dam reservoir had not been filled when the research was conducted

and the blue dash line lies to the south of the embankment dam shown in the map is the planned reservoir boundary. In the area to the west of the embankment dam, the slope inclination ranged from 3 to 20%, while in the area to the east of the embankment dam, the slope inclination ranged from 14 to 55%. With respect to the topography, an emergency spillway constructed in the area to the east of the embankment dam will likely suffer more severe erosion than that in the area to the west of the embankment dam due to a higher hydraulic gradient. Erosion of unlined earthen emergency spillway may cause failure of spillway structures and catastrophic release of reservoir waters, spillway channel bank failure, and sedimentation in the spillway exit and main channel (Cameron *et al.*, 1990).

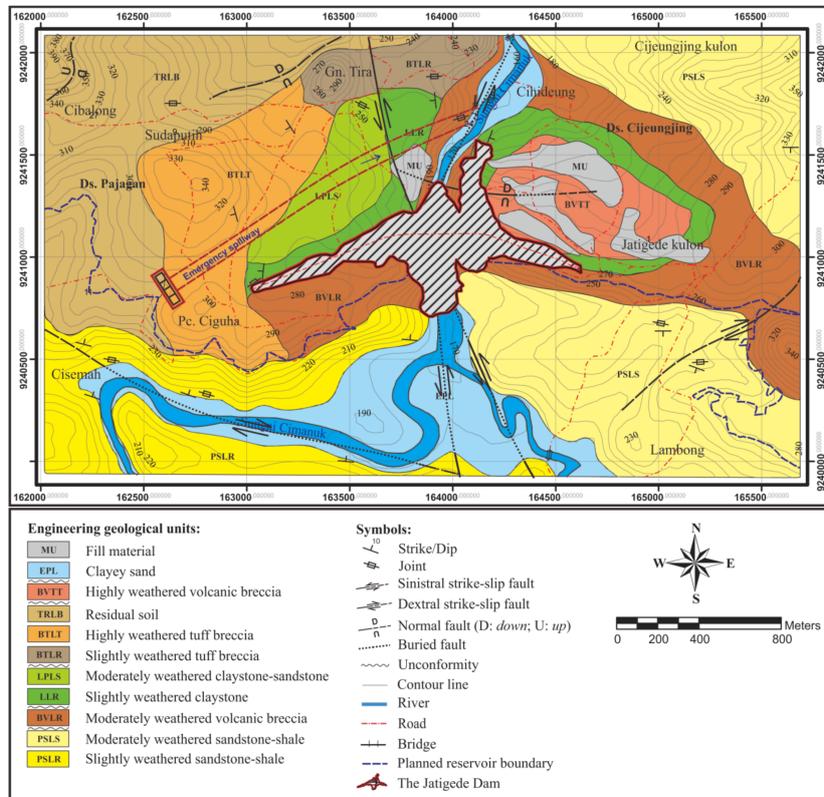
Figure 2: Engineering geological map of the research area.

The engineering geological units composing the research area are shown in Figure 2. The sandstone intercalated with shale of the Cinambo Formation exposed in the areas to the south and north-east of the embankment dam could be distinguished into the slightly weathered sandstone-shale (PSLR) and moderately weathered sandstone-shale (PSLS) unit (Figure 3). Both units were highly fractured. The slightly weathered sandstone-shale unit had a 36.9-108.9 kgf/cm² unconfined compression strength (UCS) value (Makmur, 2009). The moderately weathered volcanic breccia (BVLR) unit of the Lower Part of the Halang Formation, which was largely exposed in the area to the east of the embankment dam, was highly fractured and had a 60-95% rock quality designation (RQD) value and a 69.1-127.2 kgf/cm² UCS value (Makmur, 2009) (Figure 4a). The slightly weathered claystone (LLR) unit of the Upper Part of the Halang Formation, which was exposed in the areas to the north-east and north-west of the embankment dam, and the moderately weathered claystone-sandstone (LPLS) unit of the Upper Part of the Halang Formation, which was exposed in the area to the north-west of the embankment dam, were also fractured (Figure 4b and Figure 4c-d). The claystone unit is essentially impermeable to water flow. Due to weathering and fracturing, however, the rock unit generally had up to 5 Lugeon permeabil-

Figure 2 also shows a number of faults existing in the research area, including the large north-south strike-slip faults along the Cimanuk River and perpendicular to the embankment dam. With respect to the existence of fault systems, both areas to the west and to the east of the embankment dam will likely be influenced by similar conditions. Although the existing faults in the research area are not active faults (PT. Indra Karya Consulting Engineer, 2013), caution must be taken when an unlined emergency spillway to be constructed crossing the strike-slip fault at the contact between the slightly weathered claystone (LLR) and moderately weathered claystone-sandstone (LPLS) units in the area to the west of the embankment dam or crossing the normal fault cutting the highly weathered volcanic breccia (BVTT) unit of the Undifferentiated Old Volcanic Products in the area to the east of the embankment dam since the fault zones may induce uncontrolled seepage.

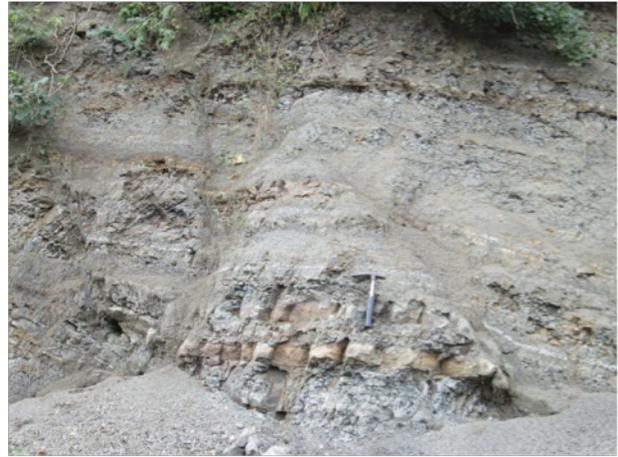
Figure 3: Moderately weathered and fractured sandstone-shale (LPLS) of the Cinambo Formation.

ity value (Makmur, 2009). The slightly weathered tuff breccia (BTLR) and highly weathered tuff breccia (BTLT) units of the Folded Breccia Formation exposed in the area to the west of the embankment dam had a 0-100 Lugeon permeability value, where the upper range of permeability value was the characteristics of the highly fractured and weathered tuff breccia unit (Makmur, 2009) (Figure 4e). The residual soil (TRLB) unit in the top left corner of the map was essentially a weathering product of the tuff breccia of the Folded Breccia Formation and had up to a 40 kgf/cm² UCS value (Makmur, 2009). The clayey sand (EPL) unit of the unconsolidated Alluvial and Talus Deposits was exposed in the area along the river. The fill material (MU) unit located to the east of the embankment dam partly covered the area underlain directly by the highly weathered volcanic breccia (BVTT) unit of the Undifferentiated Old Volcanic Products (Figure 4f). The fill material (MU) unit was essentially a geogrid reinforced soil and a graded soil foundation of gabion gravity retaining walls for slope stabilization and erosion control. The earth retaining structures were installed in the area composing of the highly weathered volcanic breccia (BVTT) unit because the area had been very susceptible to landslide, as discussed in the paragraph of landslide susceptibility zoning below.

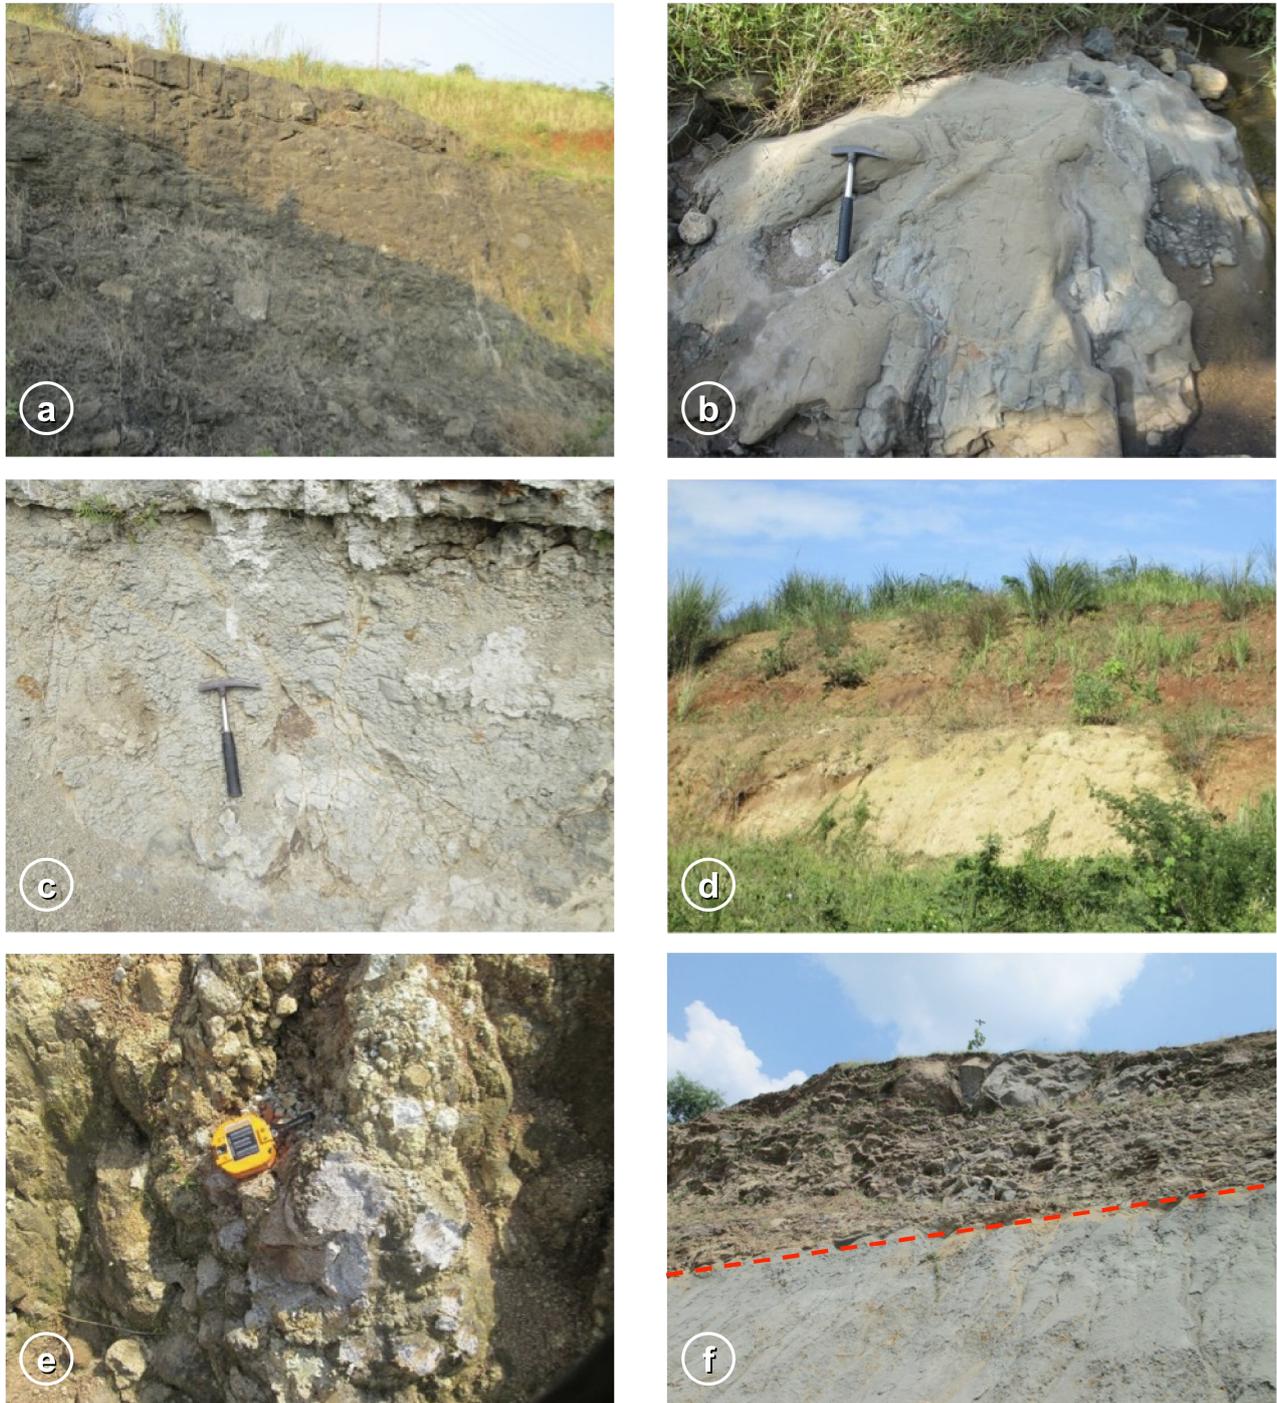
Figure 4: a) Moderately weathered volcanic breccia (BVLR) of the Lower Part of the Halang Formation. b) Slightly weathered and fractured claystone (LLR) of the Upper Part of the Halang Formation. c) Moderately weathered and fractured claystone. d) Moderately weathered tuffaceous sandstone (bottom) of the claystone-sandstone (LPLS) of the Upper Part of the Halang Formation. e) Highly weathered tuff breccia (BTLT) of the Folded Breccia Formation. f) Highly weathered volcanic breccia (BVTT) of the Undifferentiated Old Volcanic Products on top of slightly weathered claystone (LLR) of the Upper Part of the Halang Formation.

in the area to the west of the embankment dam will likely cut through the highly weathered tuff breccia (BTLT), moderately weathered claystone-sandstone (LPLS), and slightly weathered claystone (LLR) units. The highly weathered tuff breccia (BTLT) unit will likely be vulnerable to erosion by flood water. Meanwhile, an emergency to be constructed in the area to the east of the embankment dam will likely cut through the slightly weathered claystone (LLR), highly weathered volcanic breccia (BVTT), and fill material (MU) units. The highly weathered volcanic breccia (BVTT) and fill material (MU) units will likely be vulnerable to erosion by flood water. Although both areas composed of less erosion resistant rock units, the existence of fill material (MU) units and the earth retaining structures in the area to the east of the embankment dam will likely limit the flexibility in developing the emergency spillway route. In other words, the area to the west of the embankment dam is more favorable for construction of the emergency spillway.

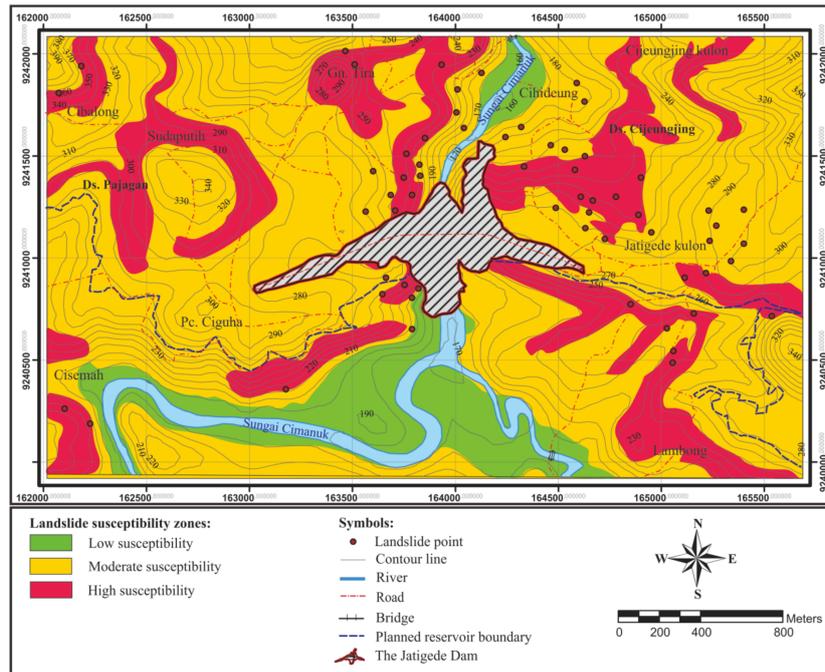
Figure 5: Landslide susceptibility map of the research area.

Figure 5 shows the landslide susceptibility zones in the research area. In general, the result of the landslide susceptibility zoning obtained from this research is in a reasonably agreement

with the Regional Map of Landslide Susceptibility Zone of Arjawinangun Sheet (Sugalang and Sugiyanto, 1994), which indicates that the Jatigede area is located in the moderate to high susceptibility to landslide. The hilly areas of the research area are characterized by a moderate to high class of susceptibility to landslide, while the river valleys are characterized by a low class of susceptibility to landslide. Figure 5 also shows that the previous landslides occurred mainly in the high susceptibility zones, implying a reasonably high accuracy of landslide prediction using the adopted method. The slope inclination and material engineering properties appear to dominantly control the susceptibility of the research area to landslide.

In the area to the west of the embankment dam, the relatively steep slopes along the Cimanuk River were highly susceptible to landslide (Figure 5). Meanwhile, in the area to the east of the embankment dam, the hilly area composed of the highly weathered volcanic breccia (BVTT) unit of the Undifferentiated Old Volcanic Products was highly susceptible to landslide. Landslide may cause damage to the emergency spillway structure or block the emergency spillway channel and those two zones of high susceptibility to landslide should be avoided for construction of the emergency spillway. However, since the area to west of the embankment dam had relatively a smaller number of landslide cases and less area of high susceptibility to landslide than the area to the east of the embankment dam, the area to west of the embankment dam is likely more favorable for construction of the emergency spillway.

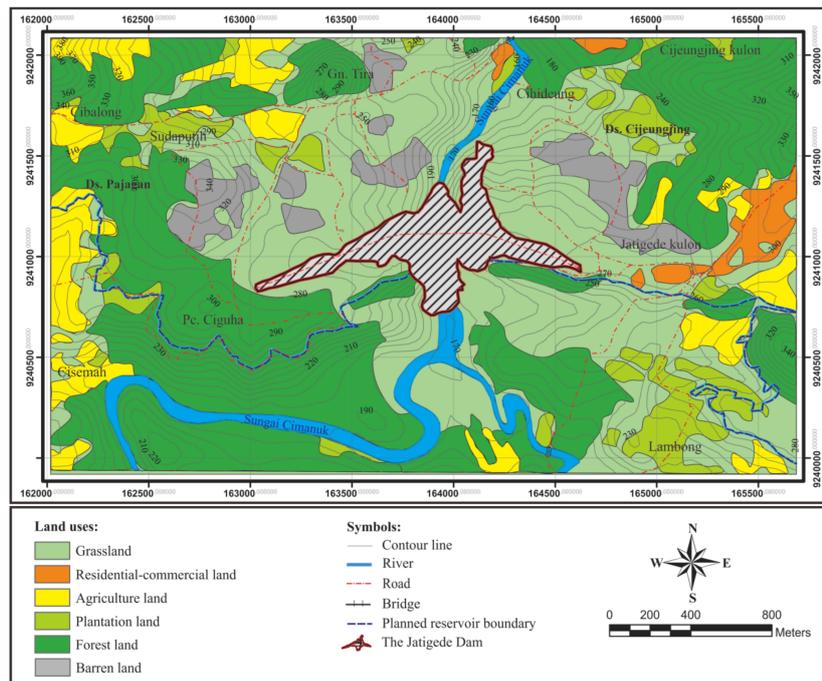
Figure 6: Land use map of the research area.

Figure 6 shows a map of the existing land uses in the research area that consisted of a grassland, mixture of residential and commercial land, agriculture land, plantation land, forest land, and barren land. The main access road from a nearby city (i.e., Cirebon) to the embankment dam passed through the residential-commercial zone, which was located to the east of the embankment dam. An access road to the area to the west of the embankment dam was provided through the top of the embankment dam. Since the area to the west of the embankment dam was undeveloped, therefore,

the area to the west of the embankment dam provided more flexibility in construction of the emergency spillway.

Considering the more favorable engineering geological characteristics, particularly the morphology, engineering properties of the soil cover and rock, geological structure, susceptibility to landslide, and land use, the emergency spillway is, therefore, proposed to be constructed in the area to the west of the embankment dam, as shown in Figure 2. The nearly straight emergency spillway route is expected to take the flood water shortly to the Cimanuk River downstream behind the embankment dam.
