RESEARCH ARTICLE

Evaluation of surface roughness of the bracket slot before and after burning

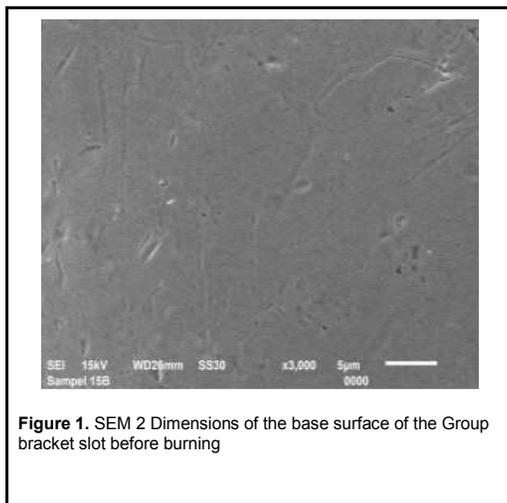
Based on Figure 1 above, it is revealed that the base surface of the slot from the group before burning looks smooth without having obvious damages caused by the burning process. Figure 2 shows that the base surface of the slot from group A which has been burned for 5 seconds with a temperature of ± 450 °C indicates an apparent sensitization process on the base surface of the bracket slot as marked with visible grain boundaries due to the burning process and visible small holes.⁶ Other visible damages are in the form of deformation with elongated grooves.

Figure 1. SEM 2 Dimensions of the base surface of the Group bracket slot before burning

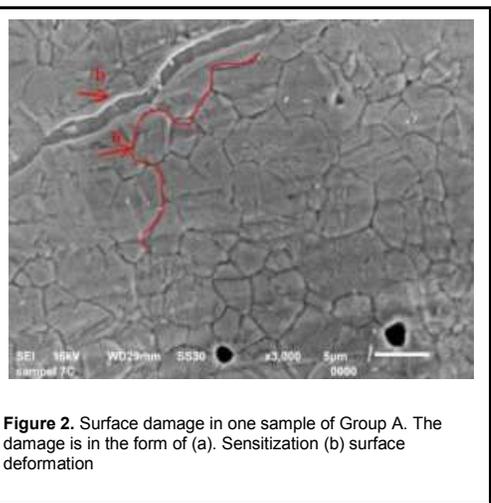
Figure 2. Surface damage in one sample of Group A. The damage is in the form of (a). Sensitization (b) surface deformation

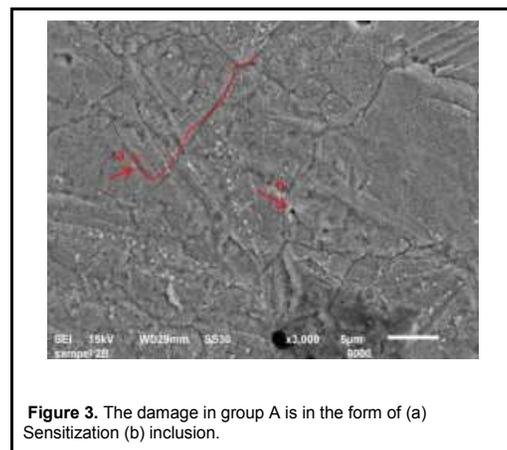
Figure 3 shows a surface damage in the form of sensitization with a marked grain boundary and small hole damage known as inclusion. Figure 4 is a picture taken from a group B showing a sensitization process that is marked by visible grain boundaries, holes caused by the release of metal elements (inclusions) and also cracks on the

Figure 3. The damage in group A is in the form of (a) Sensitization (b) inclusion.

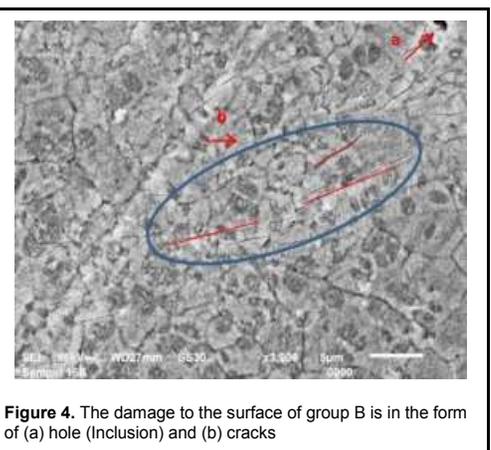
Figure 4. The damage to the surface of group B is in the form of (a) hole (Inclusion) and (b) cracks

surface that passes through grain parts caused by the high temperature of the burning process (transgranular fracture). The picture above also depicts a contrasting black and white color where white colors form a mist known as scale.^{7,8}

slot due to microstructural changes. Hence, orthodontic practitioners are expected to no longer recondition the bracket by means of burning when the bracket comes loose to avoid adverse effects that can hinder treatment or adversely affect the patients.
