# Potential of UAV-Generated Orthophotos in Assessing Environmental Vulnerability to Landslides in Ngasinan Village, Purworejo Regency, Central Java

**Abstract.** Ngasinan Village in Bener District, Purworejo Regency, has mountainous and sloping topography, which increases the risk of landslides. However, there is currently no available information regarding the village's environmental vulnerability to landslides, which is essential for disaster mitigation planning. This study aims to assess the environmental vulnerability to landslides in Ngasinan Village using orthophotos as an alternative to a census. The primary data used in this research include aerial photographs taken by an unmanned aerial vehicle (UAV) and Ground Control Points (GCPs) to ensure the accuracy of the orthophotos. The vulnerability parameters analyzed include socio-economic and physical environmental aspects. Aerial photo interpretation was used to identify building structures, the type of predominant walls, building age, building area, electricity usage, and distance from proper roads. The Digital Terrain Model (DTM) was used to extract parameters such as topographic clusters, topographic elevation, distance

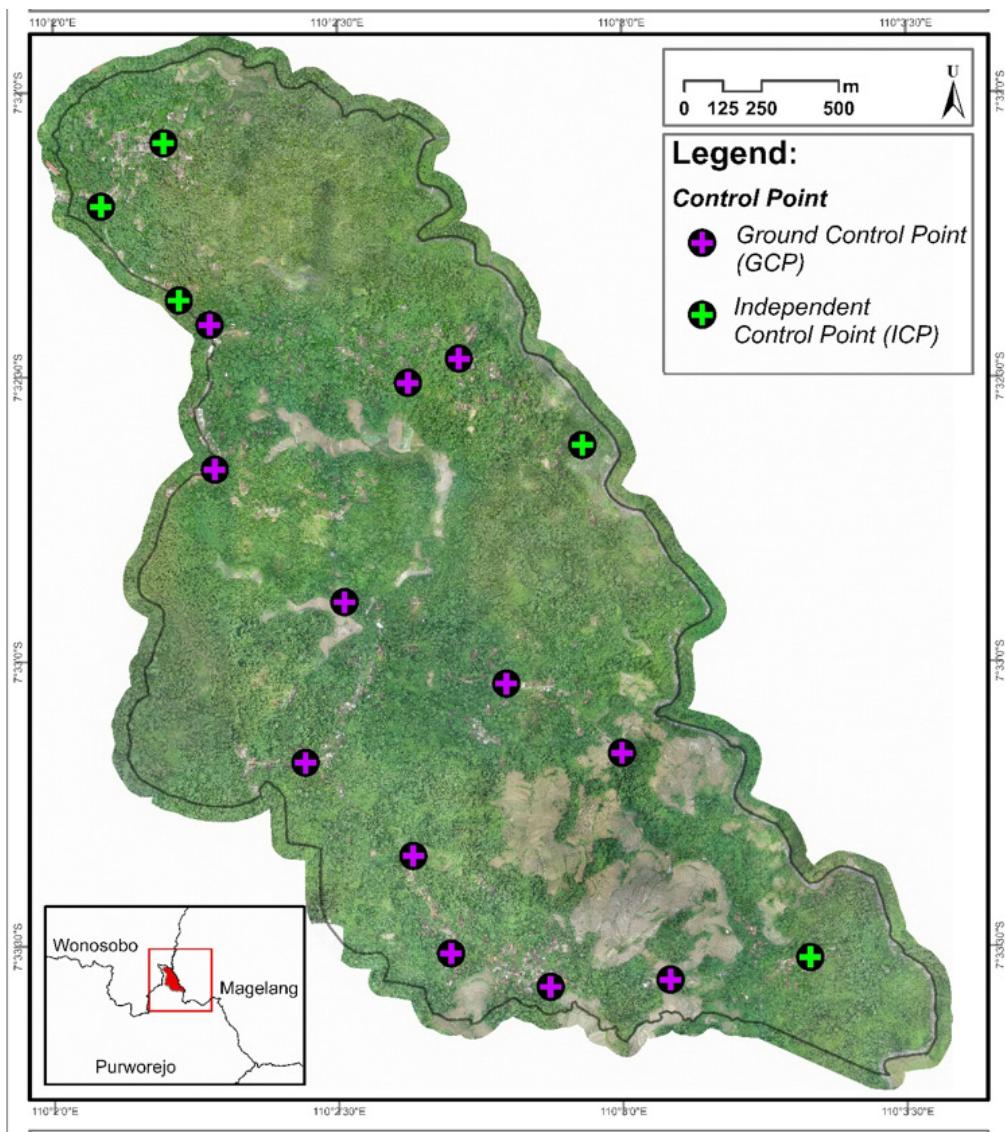
Figure 2. Distribution Map of GCP and ICP Points in the Study Area

GCP locations were chosen in areas with open vegetation cover. The distribution of GCPs considered both the edge and center of the study area, as well as varying site characteristics. Location features such as ridges, valleys, or relatively flat areas resulted in varying distances between GCPs (see Figure 2). Independent Check Points (ICP) were used to test the accuracy of geometrically corrected images against the GCPs. The orthophoto of Desa Ngasinan has a Horizontal Root Mean Square Error (RMSE) of 0.52 and a CE90 value of 0.79. The Vertical Root Mean Square Error (RMSE) is 1.15, and the

LE90 value is 1.89. The orthophoto has a CE90 value suitable for mapping at a scale of 1:5,000 and an LE90 value suitable for mapping at a scale of 1:10,000 (BIG, 2014; BIG, 2018). The distribution of ICPs is shown in Figure 2.

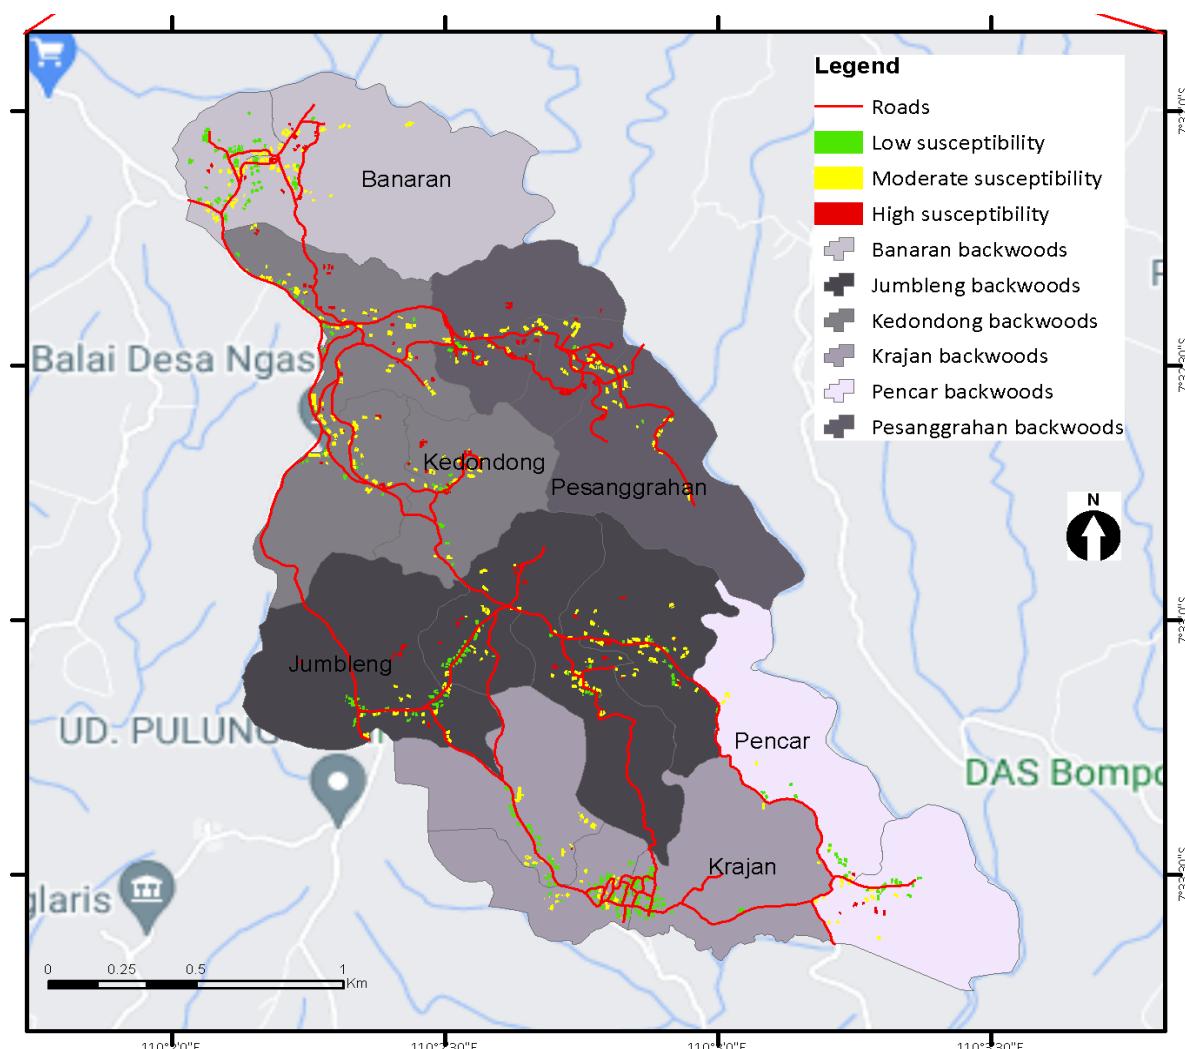
Figure 3. Map of the Distribution of House Vulnerability Classes to Landslides

The assessment of environmental vulnerability to landslides in Ngasinan Village, Bener District, Purworejo Regency, reveals that the area is predominantly categorized as having moderate vulnerability. Specifically, 315 houses fall into the moderate vulnerability category, 215 into the low category, and 77 into the high category, as detailed in Table 3. The socio-economic parameters indicate that while the physical condition of most houses in Ngasinan Village is generally good, the positioning of these buildings relative to the environment places a significant number of them in the high-vulnerability category. The distribution of houses across different vulnerability classes is visually represented in Figure 3.

In conclusion, the environmental vulnerability assessment of Ngasinan Village based on orthophoto analysis provides a high level of accuracy. The spatial distribution of house vulnerability to landslides (Figure 3) is consistent with

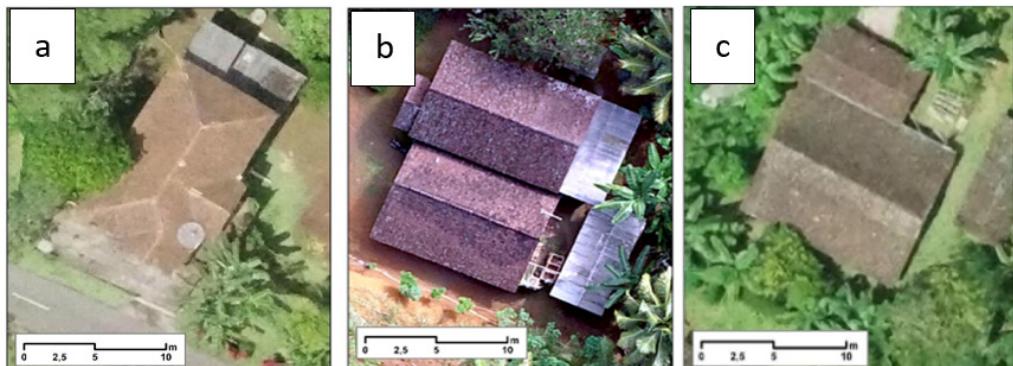
Figure 4. Roof Types: a) Limasan Roof, b) Gable Roof, c) Srotongan Roof

The architecture of houses in the study area reflects the local Javanese style, typical of buildings found in hilly rural areas. The **limasan** roof style (Figure 4.a) is indicative of buildings with robust construction and high-quality materials. This roof type is supported by a strong structural framework,

with walls typically made of brick or concrete, a deeply set foundation, and reinforced concrete joints. Similarly, the **gable** roof (Figure 4.b) also has a sturdy support structure, which can be made of either concrete or wood. The walls of these houses are constructed from various materials such as brick, concrete, or adobe, with varying degrees of quality. The foundation is well-embedded, and the joints are reinforced with concrete. On the other hand, the **srotongan** roof (Figure 4.c) is generally associated with less durable structures, often using wood and bamboo for the roof support, with walls made of wood or woven bamboo. These houses typically have foundations above ground and lack reinforced concrete joints.

The study's findings show that houses with **limasan** or **gable** roofs and concrete structures have a lower susceptibility to landslides compared to those with **srotongan** roofs and wooden or bamboo structures. Better building structures usually correlate with the use of higher-quality roofing materials. Good quality roofs retain a bright hue even as they age, which is an indicator of their durability. A well-maintained roof, supported by a strong building structure, enhances the capacity of the house to withstand external loads. These findings are consistent with previous research conducted by Setyawan (2016), Subasinghe & Kawasaki (2021), and Agliata et al. (2022).

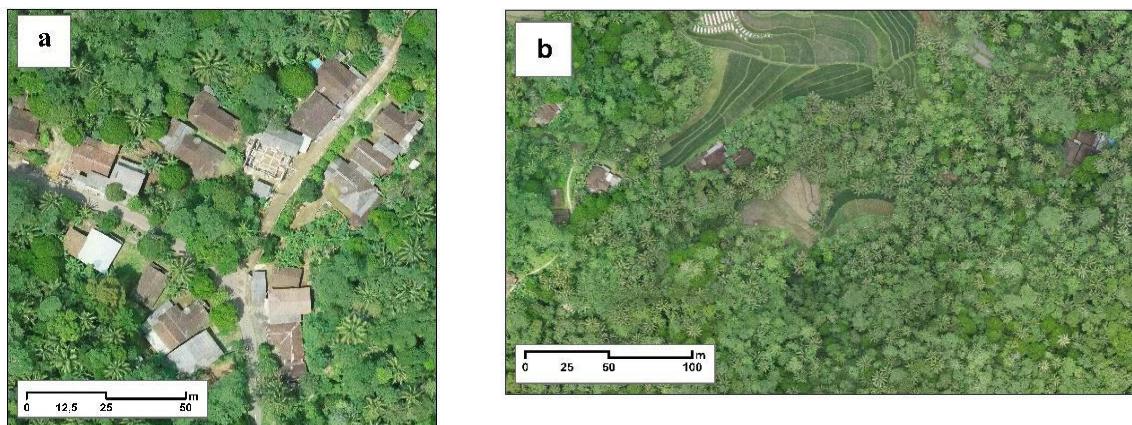
Figure 6. a) House located near a decent road b) House located far from a feasible road

Houses categorized under high vulnerability are generally located far from proper access roads (Figure 6). Proximity to well-maintained roads reduces the socio-economic and environmental vulnerability of households. However, in Ngasinan Village, some communities still rely on dirt roads

with gentle to steep slopes, and in some areas, the roads are only accessible by foot. Constructing well-built houses and providing affordable socioeconomic facilities are crucial for improving the comfort and quality of life for these families.

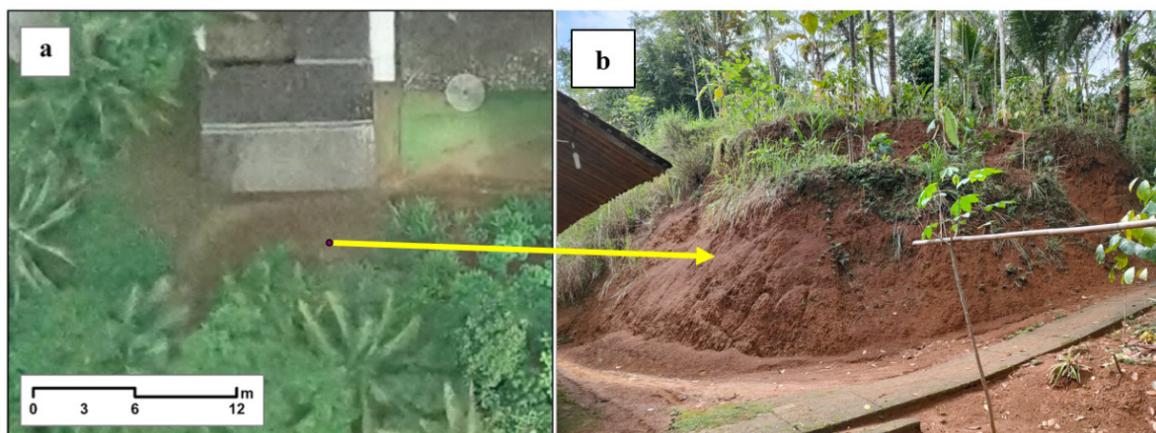
Figure 7.a) Residential landslide seen from orthophoto b) Field photo

In addition to poor road access, many houses are situated near steep and very steep slopes, which are prone to landslides (Figure 7). These houses, often located in clusters on sloping terrain, are generally not served by proper road access or drainage networks. The surrounding slopes typically have low vegetation density and exposed soil, both of which increase the risk of landslides. Landslides on these steep slopes pose a significant threat to nearby buildings, potentially causing structural damage or even destruction. Moreover, very steep slopes with sparse vegetation present a high risk of landslides, particularly in areas where community roads are present, as landslides can block access routes and further isolate the community.

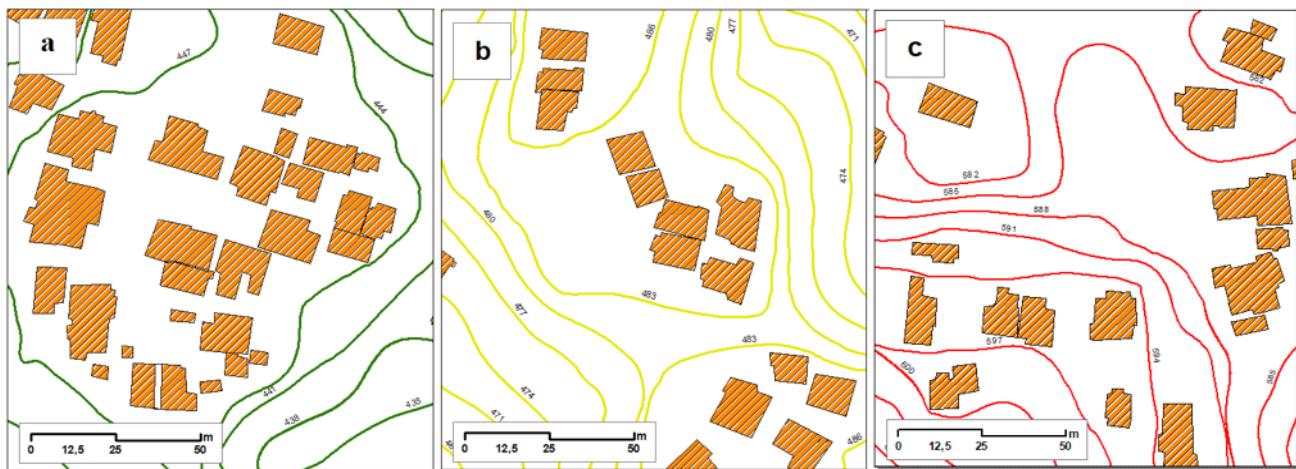
Figure 8. a) Buildings at an altitude below 450 meters above sea level (masl) (b) Buildings at an altitude between 450 and 550 meters above sea level (masl) (c) Buildings at an altitude above 550 meters above sea level (masl)

The positioning of buildings on flat ground at elevations below 450 meters above sea level (masl) appears to be safer from the threat of landslides. However, buildings located at elevations between 450-550 masl, and particularly those above 550 masl, are increasingly vulnerable. Higher elevations often correlate with steeper slopes and less flat terrain, as evidenced by the denser and more winding contour lines (Figure 8). Many of these settlements were originally established by cutting into the slopes, which further exacerbates their vulnerability to landslides.
