Environmental Degradation Analysis of Former Bengawan Solo River Lake Ecosystem

Title of the manuscript: Analysis of Environmental Degradation in Lake Ecosystems: Case Study of Lake Section of the Former Bengawan Solo River in Grogol District, Sukoharjo Regency

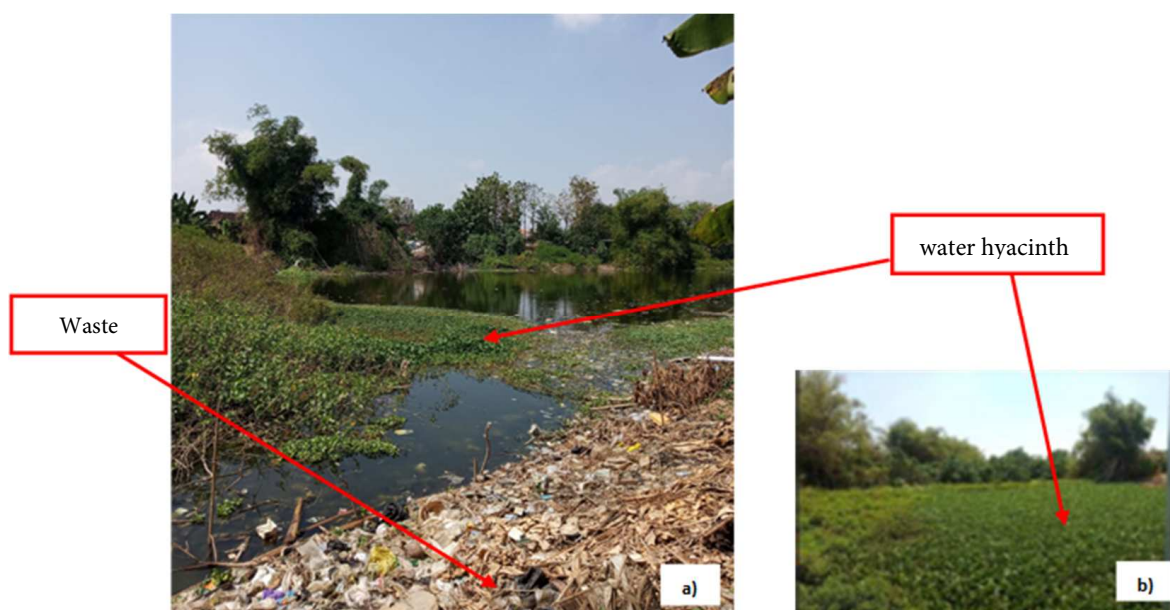
Figure 3. (a) illustrates the existence of refuse and water lily in the DPP lake ecosystem, whereas (b) portrays the occurrence of water lily in the DTPP lake ecosystem

of pollutant sources in the surrounding areas of the lake, such as domestic waste. The elevated concentrations of contaminants in the lake are likewise signified by the existence of water hyacinth flora, which act as a bioindicator of elevated metal contamination (Newete et al., 2014) (González et al., 1989) and can also reveal acidity levels (El-Gendy et al., 2004).
