Engineering Geological Characteristics of Planned Construction Area of Section 5 Yogyakarta–Bawen Toll Road, Magelang, Indonesia

ABSTRACT. This paper presents the results of engineering geological mapping conducted in Section 5 of the Yogyakarta-Bawen toll road and tunnel construction area and its surroundings. This research aimed to evaluate the characteristics of the study area's geomorphology, lithology, and geological structures to assess potential geological hazards during and after the toll road and tunnel constructions. This research was conducted by collecting geomorphological and geological data by surface mapping, which was not done in the previous site investigation. The surface mapping results show that the study area is at the geomorphological units of steep and gentle slope volcanic hills. The study area consists dominantly of tuff and tuff breccia units. At the surface, the rocks are extremely weathered. The geological structures controlling the study area are extensional joints with northwest-southeast and northeast-southwest orientation, consistent with the morphological alignment. Although the study area consists dominantly of hilly morphology and extremely weath

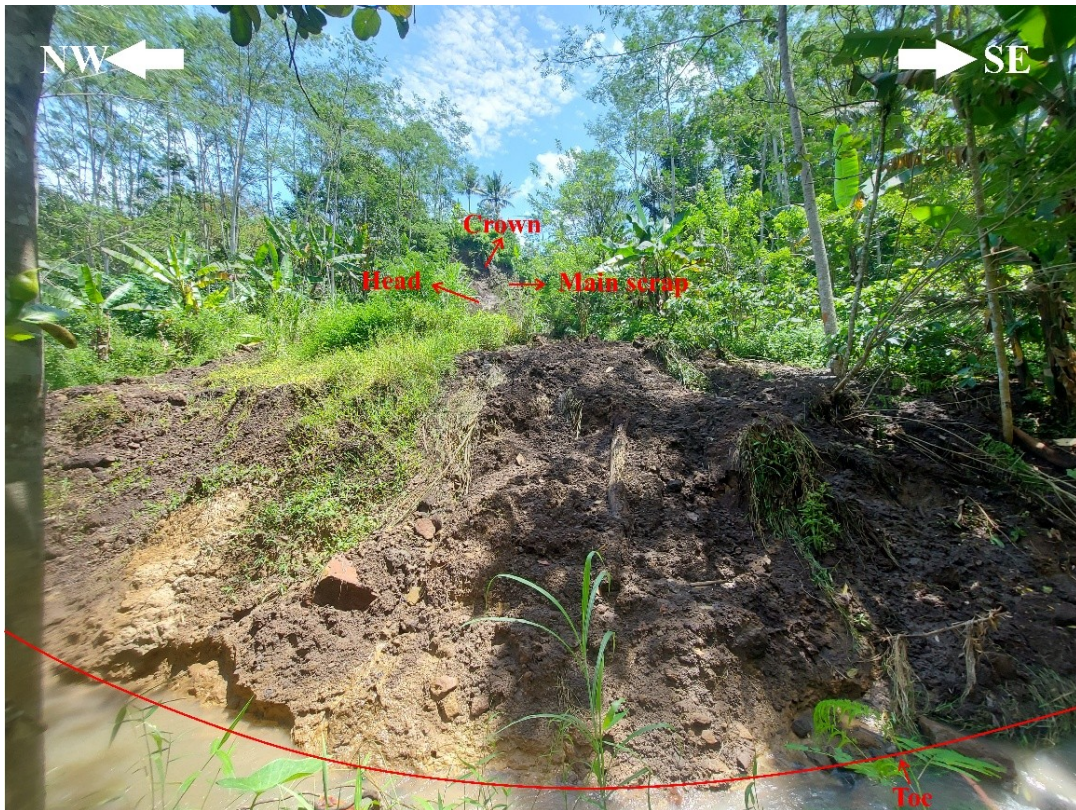
FIGURE 5. Typical landslide observed in the study area.

river, most of which are shallow. Landslides with large dimensions were only found at one point, at the northern part of the outlet of tunnel B. The landslide morphology is shown in Figure 5.

Although the study area consists dominantly of hilly morphology and extremely weathered rocks, landslides are rarely observed (Figure 4). Landslides in the study area are usually shallow on river slopes less than 5 meters high. One of the largest landslides found was close to the outlet of tunnel B (Figure 5). This may be attributed to the land use and relatively high friction angle of the weathered pyroclastic rocks comprising this area. The study area has been developed mainly as a plantation area.

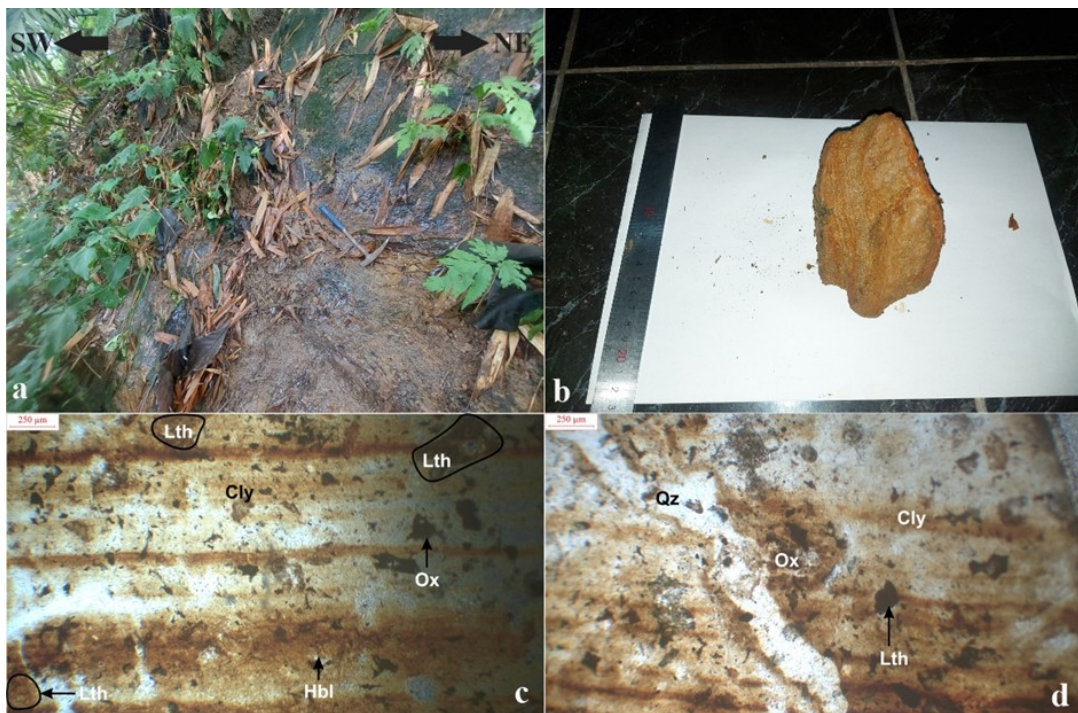
FIGURE 9. (a) Outcrop of lithic tuff. (b) hand specimen sample of lithic tuff. (c) Microphotograph of lithic tuff showing laminated structure. (d) Microphotographs of lithic tuff show a quartz vein filling the microfracture. Hbl = hornblende, Cly = clay, Ox = oxide minerals, Lth = lithic, and Qz = quartz.

Microscopically, this rock has a grain size of <2 mm – 3 mm, has a laminated structure, has a sub-rounded to sub-angular grain shape, and the rock composition is lithics, quartz, volcanic glass, hornblende, clay minerals, and iron oxide minerals. The rock matrix comprises volcanic glass, hornblende, and clay minerals. Fragments are composed of lithics and iron oxide minerals. The quartz in this rock is present as veins that fill fractures in the rock. The fractures are so minor that they cannot be seen on a megascopic view. The lithic tuff is named after Fisher's classification (1966). The outcrop, hand specimen sample, and microscopic observations of the lithic tuff can be seen in Figure 9. At the surface, the lithic tuff is mostly highly weathered.

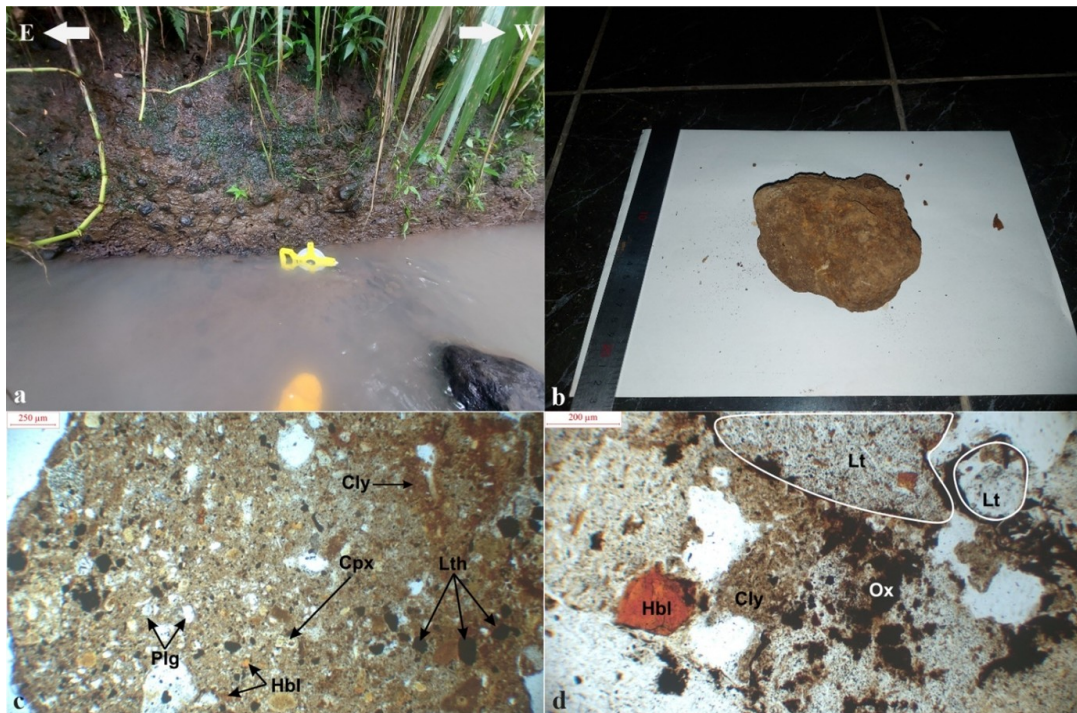
FIGURE 10. (a) Outcrop of tuff breccia. (b) hand specimen sample of the fragment of tuff breccia. (c) and (d) Microphotographs of tuff breccia. Hbl = hornblende, Plg = plagioclase, Cly = Clay, Ox = oxide minerals, and Lth = Lithic.

Documentation of the outcrops, hand specimen samples, and microscopic observations of the tuff breccia can be seen in [Figure 10](#). At the surface, the tuff breccia is dominantly extremely weathered. Highly weathered tuff breccia is only observed at the river slopes. Engineering properties of the weathered tuff breccia are shown in [Table 3](#). Based on the International Society for Rock Mechanics and Rock Engineering (ISRM) (1978), the tuff breccia is classified as a very weak rock.
