Hydrology and Hydraulic Analysis of Nasiri Flash Flood Disaster Event on the 1st August 2012

ABSTRACT

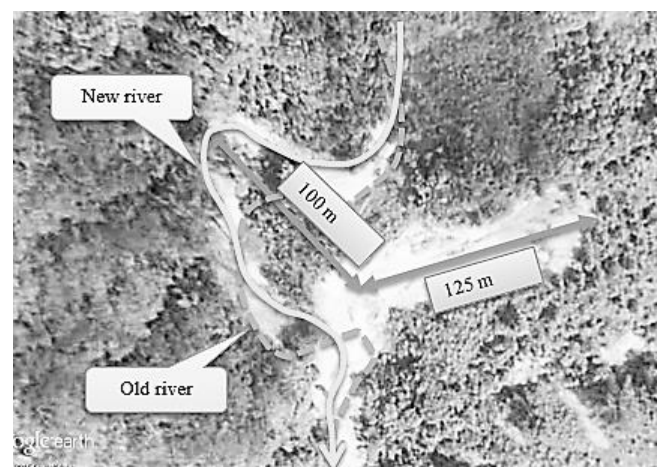
Figure 4. Image from the Google satellite on October 8th, 2012.

Google satellites recorded an avalanche and river flow path in the upstream of Nasiri. It lied ±1.5 km from the people settlements at the altitude of +53 meters above sea level (MASL). Figure 4 shows the evidence of an avalanche on the river bank, while Figure 5 presents 3 (three) locations that allegedly occurred landslide. Landsat images could not display clearly because of its 30×30 meters resolution.

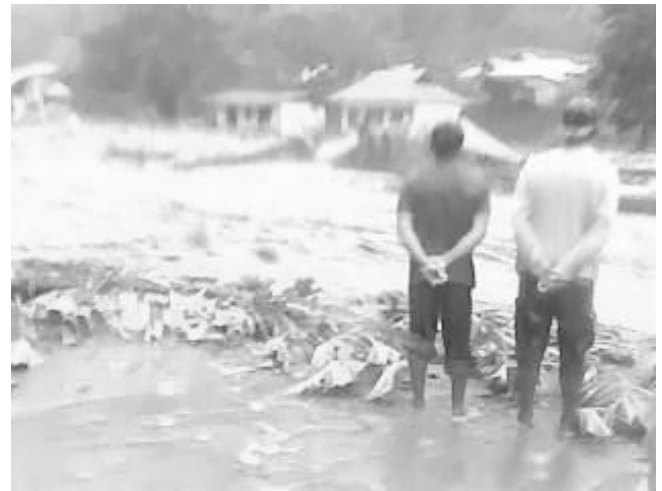
Figure 14. A captured image from video recording during the flood (Hidayatulloh, 2017).

A resident was documenting the flood events with his phone video camera. It was a very rough video, but it could illustrate the magnitude of the flood (Hidayatulloh, 2017). From Figure 14 it appeared that flood flow was very fast (± 5.4 m/s) and muddy, swept away trees, and have destroyed many houses. Predicted discharge is $54.16 \text{ m}^3/\text{s}$ at 14:38 PM (UTC+9).

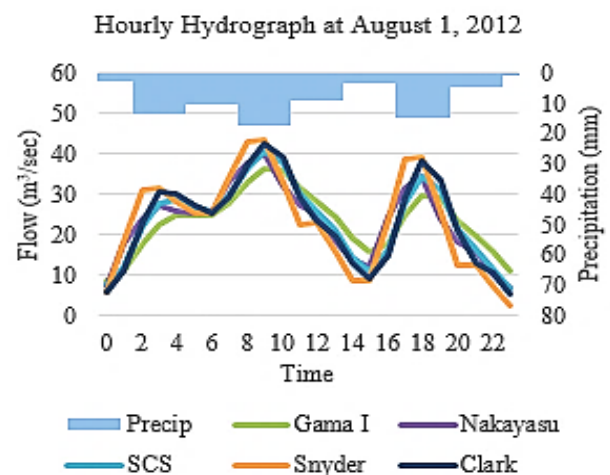
Figure 16. Hourly hydrographs on August 1st, 2012

Five synthetic unit hydrographs (SUHs) were compared to view the peak flood at 10:00 AM on August 1st, 2012. HEC-HMS simulation result without landslide dam is shown in Table 9 and Figure 16.

There are differences between SUHs in Figure 16 and Table 6. Peak flow was occurred at 09:00 till 09:24, while Nasiri's residents said that the flood hit at 10:00. Approximated peak flow was more than 60 m³/s, while Figure 16 shows different results. There must be two

landslides in the river upstream. The first was before 10:00 AM and the second was before 14:38 PM.

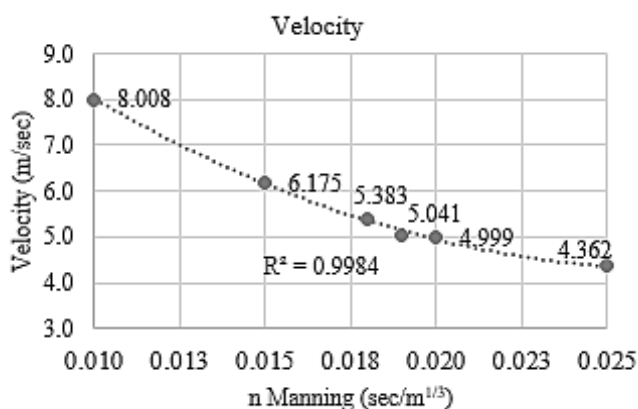
Figure 17. Rating curve for velocity.

From some of the Manning *n* values, it can be calculated the ideal value for settlements and river channel by rating curves (Figure 17). From Table 10, the value of *n* = 0.057 (MPM, 1948) resulted in the best and the maximum debit at 10:00 (UTC+9), i.e. 83.58 m³/s. As for the Manning *n* value of the river channel corresponding to the information in Section 9 was 0.018, which resulted in a velocity of 5.4 m/s.

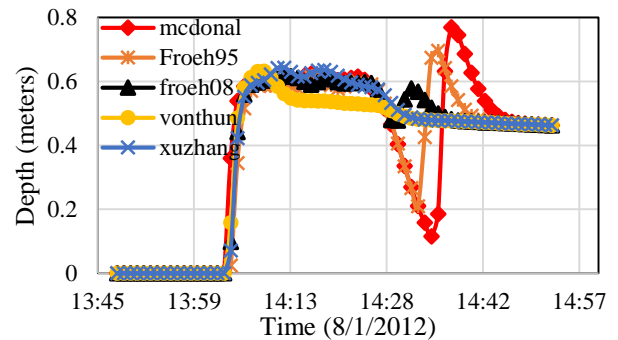
Figure 20. Flow depth at school caused by landslide dam (2).

Analog by way of the first landslide was calculated, then the calculation for flood at 14:38 was also performed. The central landslide as high as 8.96 meters at the +78.53 MASL elevation was simulated in HEC-RAS. From the HEC-HMS simulation without a landslide dam, the Nasiri River only supplies 16 – 20 m³/s of discharge at 14:00 – 15:00. In contrast to the lower landslides seen quite clearly from Google Earth imagery, the central landslide was not clearly visible from satellite imagery. So it takes several times
