# Preventing Turbine High Vibration by Upgrading the Balance Weight Material at PLTP Darajat\*

PT. Indonesia Power Kamojang POMU  
Garut, Indonesia

Due to its direct contact with high- pressure steam, the turbine rotor is an essential part of geothermal power plants. A balance weight located in the fifth stage of rotor turbine to prevent initial unbalance in the turbine rotor. Due to erosion and sulfur attacks, the balancing weight of PLTP Darajat is frequently damaged, which is evident by the formation of unbalance. On December 2020, when shutting down, PLTP Darajat encountered considerable vibration disturbance, at 1400 RPM rotation, it reached 104 m [P-P]. It was essential to balance the turbine rotor by adding a new balance weight after a borescope test revealed that balance weight erosion was 50%. An examination of the shape, erosion resistance, and sulfur resistance of the turbine balancing weight material was done to reduce the likelihood of erosion disturbances. At one time. PLTP Darajat utilized materials including SS-410, Tungsten Alloy, and 17-4PH. In this research we used the balance weight of Inconel 625 material. Next, we tested the material based on the Chromium (C

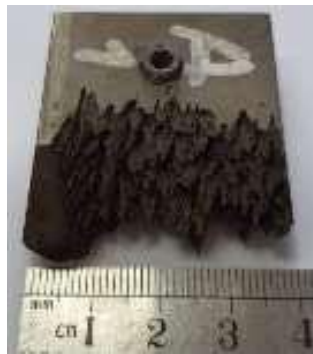
Figure 1. Erosion of the balance weight of the turbine

Figure 1 shows erosion in the balance weight of the PLTP Darajat turbine. The turbine balance weight materials used at the Darajat PLTP are SS-410, tungsten alloy, 17-4 PH, and Inconel 625.

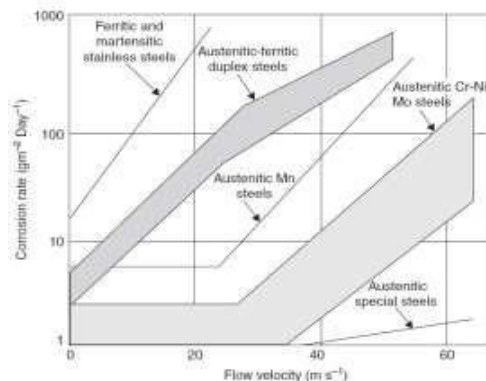
The random flow of fluid that strikes the material's surface during turbulent fluid flow mechanically erodes the protective layer. The figure 2 that follows displays the correlation between fluid flow rate and the metal loss process in various materials.

Figure 2. Relationship between Fluid Flow Speed and Mass Loss (Ridwan, 2020)

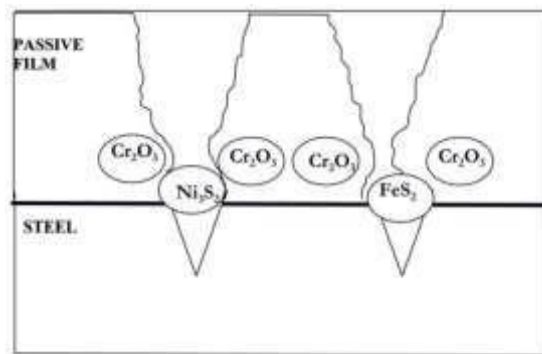
The protective oxide layer that forms on the surface has a significant impact on the stainless-steel material's ability to resist corrosion. However, several factors, including sulfur-induced corrosion, can result in the protective oxide layer being lost and the base metal component being exposed directly to the atmosphere. The SIC process on metal is illustrated in the diagram below.

Figure 3. Sulphur Induced Corrosion mechanism (Siracusa, 2004)

It is necessary to use a material with a high Cr element content, high strength, and high hardness to boost a material's resistance to sulfur attack.

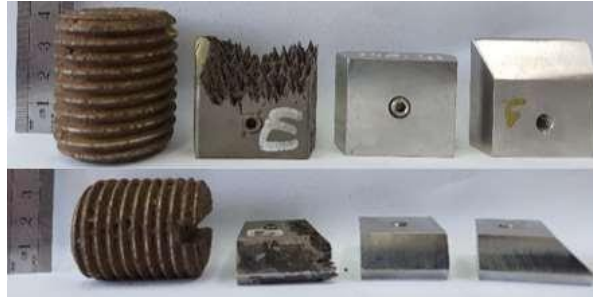
Figure 5. The balance weight design of the Turbine Rotor at PLTP Darajat

Prior to upgrading, the balance weight was attached to the sixth level blade as a thread. To optimize the aerodynamics of the steam flow and make the step more resistant to erosion problems, the balance weight was positioned on the fifth level blade and had a certain angle of inclination at the ends.
