# New Alignment Method Using Hydraulic Jack for Accelerating SWD 16 TM 410 R Engine and Generator Coupling<sup>1</sup>

ULPLTD/G Trisakti, PT. PLN Indonesia Power UPDK Barito Indonesia

## Abstract

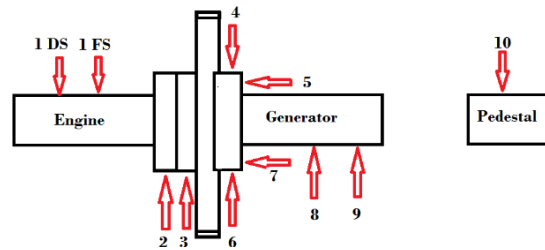
Figure 1. Dial Indicator Position for Shaft Alignment

In Figure 1, the depicted positions showcase the data collection for shaft oscillations utilizing a dial indicator. In the earlier approach, dial indicator testing was confined to the connection point between the diesel and generator, explicitly focusing on the radial (4) and axial flange generator (5). Relying solely on these 2 data points led to the assumption that the shaft was correctly installed due to the oscillations within acceptable limits at those locations. However, recognizing the extensive length of the crankshaft, we expanded our testing to encompass 9 points along the shaft, as illustrated in Figure 1. These 9 points are listed below:

1. Damper side / Flywheel side shortshaft journal
2. Shortshaft flange
3. Flywheel flange
4. Radial flange generator
5. Axial flange generator
6. Radial from earth
7. Axial from earth
8. Generator shaft radial 1
9. Generator shaft radial 2
10. Pedestal shaft radial

Within Table 2, comprehensive measurement data is presented and systematically organized for analysis. The position of each column corresponds to the points along the shaft, as indicated in Figure 1. Furthermore, each row, denoted from A to H, corresponds to precise shaft peripheral points, meticulously calculated clockwise, as shown in Figure 7. This structured arrangement allows for a clear correlation between the measured values and their respective positions along the shaft, providing valuable insights for further assessment and necessary adjustments.

Table 3 shows the dial indicator measurement results after implementing our recent breakthrough alignment method. As explained earlier, our measurements were strategically conducted at multiple designated points, illustrated in both Figure 1 and Figure 7, for a comprehensive understanding of the alignment adjustments.

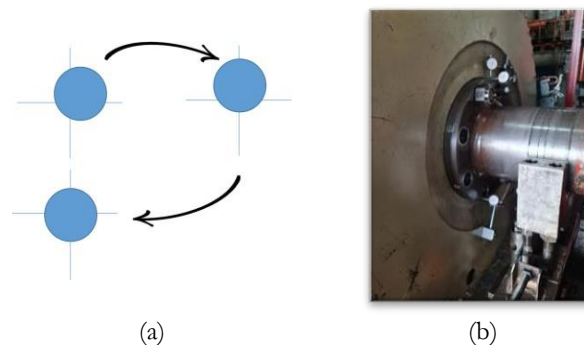
Figure 2. Old alignment method using cap main bearing (a) Illustration of the shaft alignment movement process (b) Cap main bearing for shaft Alignment Process

Upon identifying discrepancies in the dial indicator measurement results, it is evident that an alignment process is essential. In the prior method, alignment involved utilizing a modified cap main bearing, allowing for shaft movement in both the x and y directions—namely, right and left and up and down. There are two different kinds of tools that are used when the diameter and the straightness of the main bearing caps and the camshaft bearings are being measured, the laser measurement tools and the optical measurement tools. The alignment process commenced by locating the center point of the x-axis of the shaft through x-axis shifts. In the measurement records for the alignment of the main bearing caps and for the camshaft bearing caps gathered from the measurement the x-line and y-line can be seen (Mattans, 2011). From this it is very easy to see if the straightness of the bearings is within the tolerances. Subsequently, alignment was fine-tuned along the y-axis until the crankshaft precisely aligned with the center axis. Figure 2 illustrates the alignment process, displaying the shaft movement using conventional methods on the generator flange. During the engine's idle speed operation (250 rpm), it became apparent that the generator shaft movement exhibited an unbalanced nature.

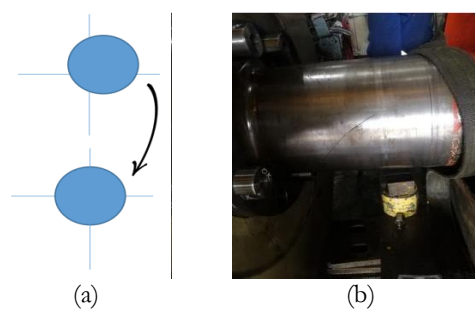
Figure 3. Breakthrough Method Using Hydraulic Jack (a) Illustration of the shaft alignment movement process (b) Hydraulic Jack for shaft Alignment Process

In a groundbreaking approach, the novel method significantly emphasizes pinpointing the most prominent diagonal deviation, departing from the conventional focus on specific x and y-axis coordinates. The integration of a hydraulic jack, illustrated in Figure 3, introduces remarkable flexibility in adjusting shaft alignment, thus substantially accelerating the overall processing time, vividly showcased in the accompanying visualization. A vigilant monitoring of dial indicator readings on the flange accompanies our meticulous control over the shaft's movement. Once these readings align with the predefined standards listed in Tabel 1, we secure the shaft and measure oscillation values along the shaft to validate the alignment process's effectiveness. The pivotal role of hydraulic jacks in relocating the generator shaft, guided by dial indicators at positions 8 and 9, is pivotal in achieving optimal alignment. The primary objective revolves around minimizing values at critical junctures, notably points 1, 2, 8, and 9, recognizing their importance in the fundamental connection between the engine (short shaft) and the generator (generator shaft).

We decide to re-align the engine. This time we use more dial indicators. And we use hydraulic jack to move the generator shaft with guidance from dial indicators at point 8 and 9. Basically, we try to minimize the value at point 1,2, 8 and 9. Because we are connecting the engine (shortshaft) and the generator (generator shaft).

Implementing a hydraulic jack in the alignment process significantly expedited the process, showcasing successful alignment within a reduced timeframe. Moreover, employing line boring for the shaft reaming process proved notably efficient, requiring a mere six days to ream eight holes. Consequently, the work process duration has been significantly reduced, notably minimizing the timeline from an initial 54 days to a remarkable 10 days. This equates to an impressive 81% reduction in the overall time required for the task.

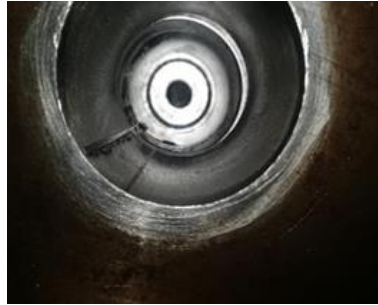
Figure 4. Holes After Alignment Process

After completing the shaft alignment, we ream the eccentric hole to accommodate the bolts. Figure 4 shows the condition of the hole after alignment. Due to the movement of the shaft, some parts of the hole do not fit properly, so a reaming process needs to be carried out.

The SWD 16 TM 410 R unit comprises eight holes that necessitated reaming. Each hole required five days to complete the reaming and bolt fitting process. The time-consuming nature of this task is due to the use of an adjustable hand-reaming tool as shown in Figure 5, requiring substantial physical effort, involving a team of 6 individuals in each session.

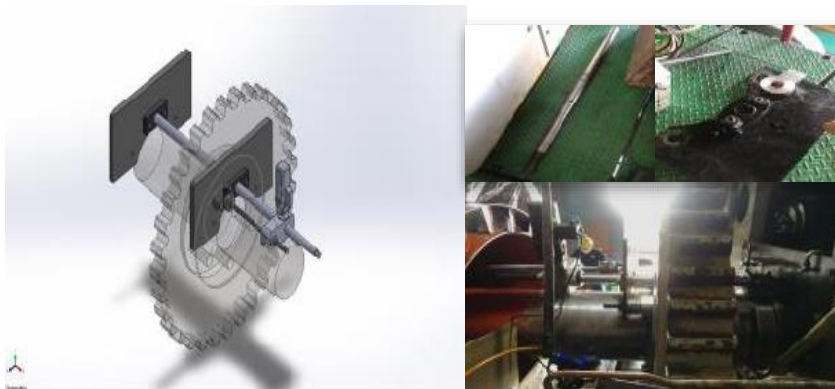
Figure 6. Line Boring Tool for Reaming

In the current stage of our project, we are faced with reaming the remaining eight holes. Using traditional methods, this task would consume a significant amount of time, approximately 40 days. Recognizing the need for a more efficient approach, we opted to innovate and design a specialized tool. This tool, presented in Figure 6, adapts a line boring tool customized to suit our reaming requirements. The implementation of this tool remarkably streamlined our operations, reducing the duration of the reaming process to a mere six days. Additionally, the manpower required was notably diminished, with only a team of 2 individuals operating this specialized tool.

This marked improvement led to a remarkable reduction in the required workforce, now streamlined to just two individuals for 4 days, in contrast to the previous necessity of 6 workers per shift. The previous approach relied on hand-reaming tools powered directly by human effort. In contrast, introducing a line boring tool streamlined the reaming process, facilitating a quicker and more manageable workload for the workers. A comparative analysis between the traditional and the new methods for both the alignment and reaming processes is detailed in the Table 4.
