## An Assessment of Derelict Building Constructions Situated in Coastal Regions

The study was conducted on the Dande Dandere Market building, located on Tanakeke Island, Takalar Regency, South Sulawesi, to examine its structure. The market was constructed as a simple reinforced concrete structure with a lightweight steel frame roof covered with span-deck steel. The market comprised three buildings: Building A, Building B, and Toilet Building, situated along the coast as depicted in Figure 1.

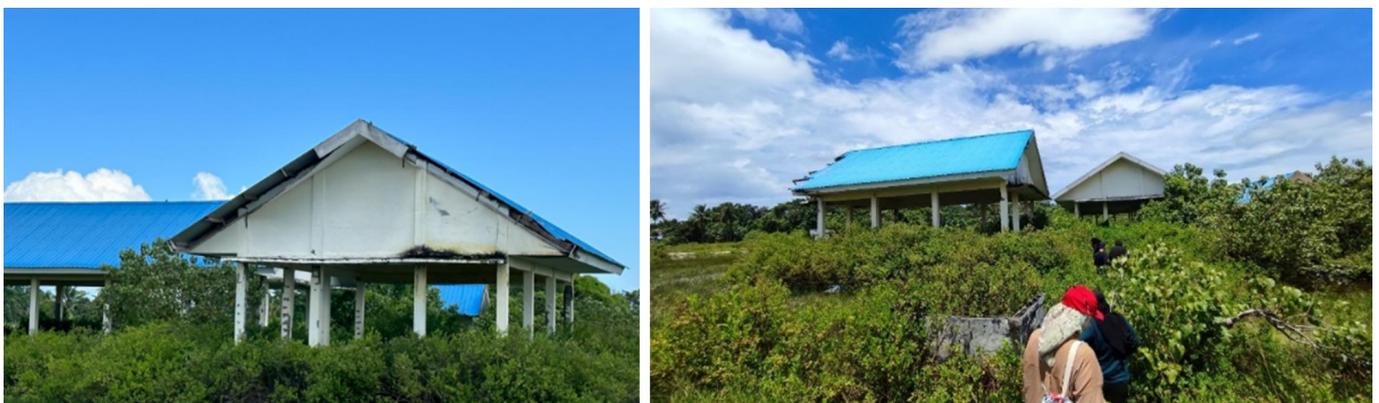
Figure 2 Condition of the market building and surroundings

The condition of the market building and its surroundings during the field visit, as depicted in Figure 2, revealed rampant wild vegetation with strong roots encroaching the area surrounding the market building, making it challenging for the team to identify Paving Block works around the building. Eventually, after a thorough exploration of these wild plants, the Paving Blocks were discovered.

Visual identification revealed structural degradation in the market's construction, occurring at a faster rate than the expected lifespan of the building. Signs of structural degradation in the reinforced concrete construction include the peeling of concrete coverings (spalling) on beam and column components, as well as on cantilever slab plates.

While observing the deteriorated upper building conditions, it was also presumed that the foundation of this market building had undergone similar, more severe conditions due to the accumulation of salt aggression and sulfuric acid from the surface soil. Based on visual identification, the soil was identified as expansive organic silty clay sand, characterized by black color. Another type of non-structural degradation involved the detachment of ceramic tiles from walls or floors and the collapse of lod's sales tables. During the team's inspection, a lods table collapsed even with only one person

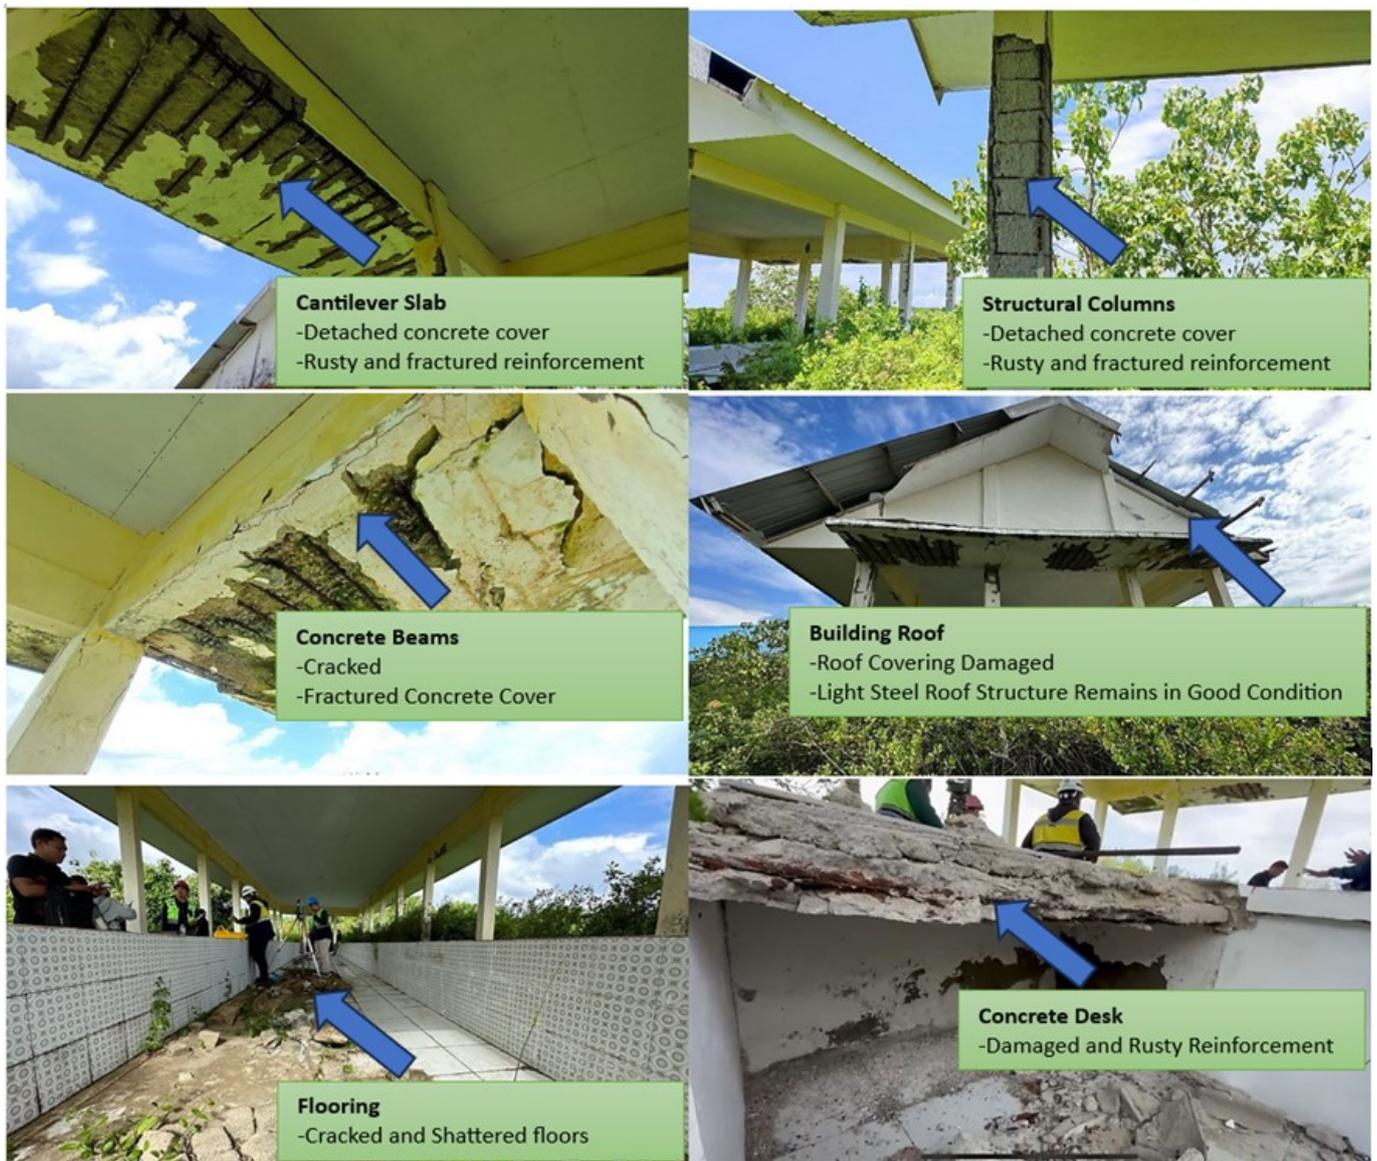
Figure 3 Identification of component damage in the building

In Figure 3, severe damage or significant degradation was evident in the structural elements of the slab, column, and beam throughout almost all parts of the con-

struction in Main Buildings A and B. This type of structural damage included cracked and expanded concrete with wide openings (more than 1.0 mm), spalling of concrete covers and corrosion, as well as severe expansion of reinforcements (rebar fracture and easy tearing). The damage depicted in the figure was attributed to the very low quality of concrete during the initial implementation, making it vulnerable to the aggressive influence of the coastal environment. Similarly, the damage has also occurred to architectural components, such as floor damage caused by soil conditions, roof and listplank detachment due to wind influence, and corrosion on nails/screws from the surrounding environment.

Based on these findings, we recommend the demolition of this building and its replacement with more efficient and effective materials suitable for coastal locations. According to Kuzman and Grošelj (2012), processed timber construction emerges as the top priority among various construction types, followed by solid timber construction, concrete construction, brick construction, and steel construction. Timber buildings offer numerous advantages, including comfort, attractiveness, versatility, affordability, ease of construction, low cost, durability, and environmental safety (Kozak and Cohen, 1999). Timber has been utilized for var-

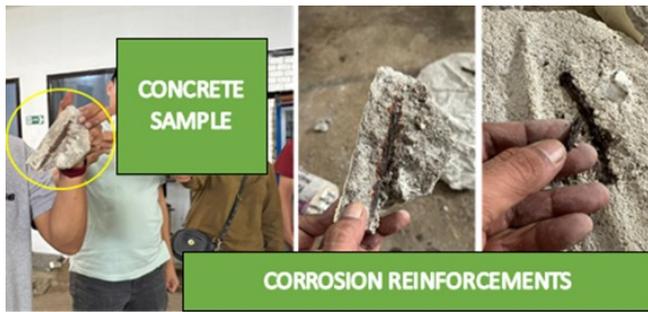
Figure 4 Samples of concrete debris from the site

Figure 4 shows white-colored debris samples with adhering reinforcements in concrete or mortar. The white

color of this debris provided an initial indication that the concrete had detached due to carbonation. Figure 5 illustrates the visual condition of reinforcement elements that have undergone severe corrosion, characterized by brittle fractured reinforcement metal and easy tearing, resulting in a reduction in the cross-sectional area of the reinforcement steel. The reduced diameter of the reinforcement due to continuous corrosion will reduce the bearing capacity of reinforced concrete elements such as beams, columns, and slabs in the market, both under tensile and compressive stresses.

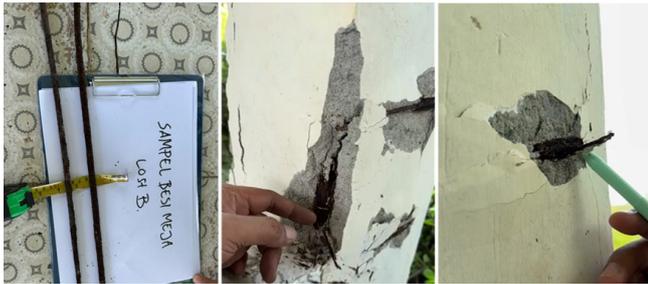
Figure 5 Rebar samples and the condition of corroded rebars that can be fractured

The results obtained from testing four reinforcement bars with an initial diameter of 12 mm revealed an average weight reduction of 62.70% over six years. This result corresponded to an average weight loss of 0.103 grams per day or a reduction in the diameter of the reinforcement bars by  $2.0 \mu\text{m}$  per day over the six years. Considering that the reinforcement bars served as components for both compression and tension reinforcement in reinforced concrete, such rapid dimensional reduction (from a diameter of 12 mm to approximately 7.33 mm over approximately six years), it can be inferred that the structural integrity of the market building was significantly decreased. This degradation was attributed not only to the deterioration of concrete material but also to the reduction in diameter and quality of the reinforcement bars.

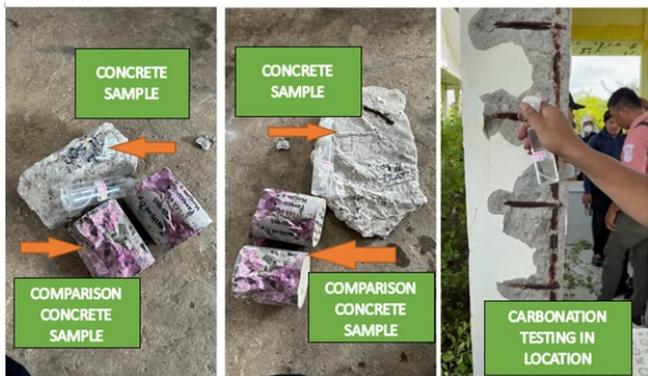
Figure 6 Results of carbonation testing on concrete debris and structural elements

The results of carbonation testing on concrete samples are depicted in Figure 6. The figure illustrates a noticeable difference in the surface color of two types of samples from different sources. Concrete chip samples from the location of Dande Dandere Market, Tanakeke Islands, exhibited no color change after being sprayed with phenolphthalein solution. This result suggested an increase in calcium carbonate content on the surface of these concrete chips, shifting the pH of the reinforced concrete from alkaline to acidic conditions. In contrast, the reference sample used in this test, a laboratory core drill specimen with concrete, remained alkaline. Upon spraying with phenolphthalein solution, it immediately changed color to pink or purple. Similarly, direct spraying of the same solution on the surface of a peeled column structural element showed no color change, indicating that the reinforced concrete had undergone carbonation.

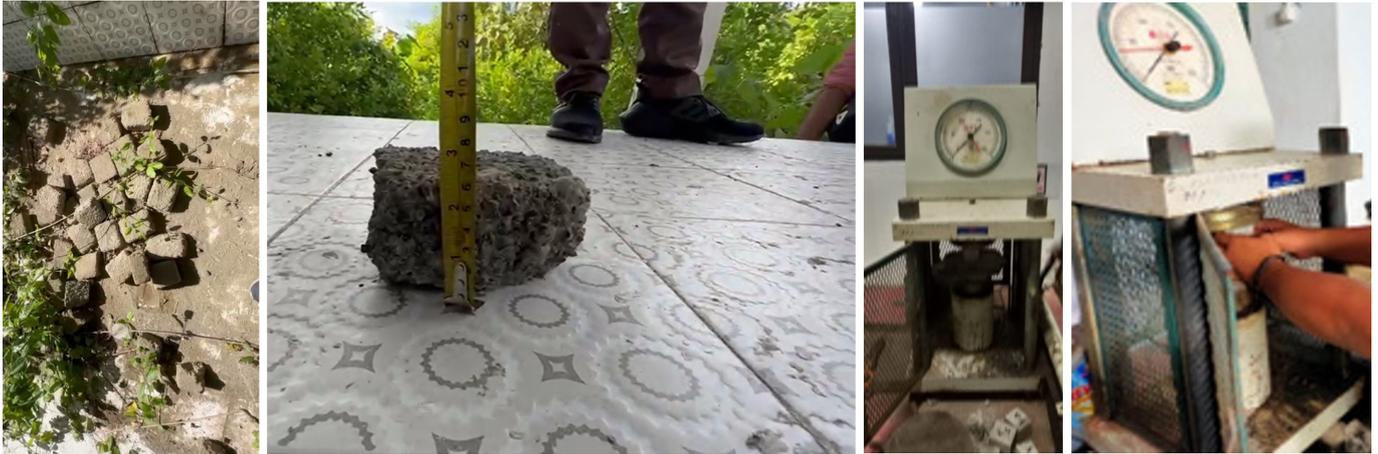
Figure 7 Compression strength testing of paving blocks sample (left) and testing apparatus (right)

standard size for compressive strength test specimens. The testing of Paving Block samples is shown in Figure 7. The average compressive strength test result of five  $5 \times 5 \times 5 \text{ cm}^3$  cube specimens obtained a value of 11.45 MPa, which was only about 46% of the planned strength of 24.90 MPa. Similarly, the relative density of concrete, determined by weighing the test specimens in dry conditions, was obtained at  $2.29 \text{ grams cm}^{-3}$ . This result represented a decrease of 4.6% from the weight of the paving block, which commonly exceeded  $2.4 \text{ grams cm}^{-1}$ .
