# Seismic Performance of Reinforced Concrete Buildings in Darchula, Nepal: A Fragility-Based Approach

**ABSTRACT** This research evaluated the seismic vulnerability of non-engineered reinforced concrete (RC) buildings compared with that of engineered RC structures in the Darchula region of Far-Western Nepal, an area prone to high seismic risk. This study emphasizes the seismic performance of buildings under various loading conditions by examining construction practices and identifying structural deficiencies in RC buildings in Darchula, Nepal. Linear elastic and nonlinear pushover analyses are used to assess periods, mass participation, base shear, inter-story drift, capacity curves, nonlinear drift demand, and fragility curves. Models designed according to national and international standards are compared with non-engineered buildings (S1 – S6) to highlight the discrepancies in seismic resilience. The study further provides a probabilistic fragility framework to quantify damage likelihood at varying seismic demand levels. The results show that engineered buildings exhibit significantly greater resistance to seismic forces, with greater flexibility and higher base shear capacities

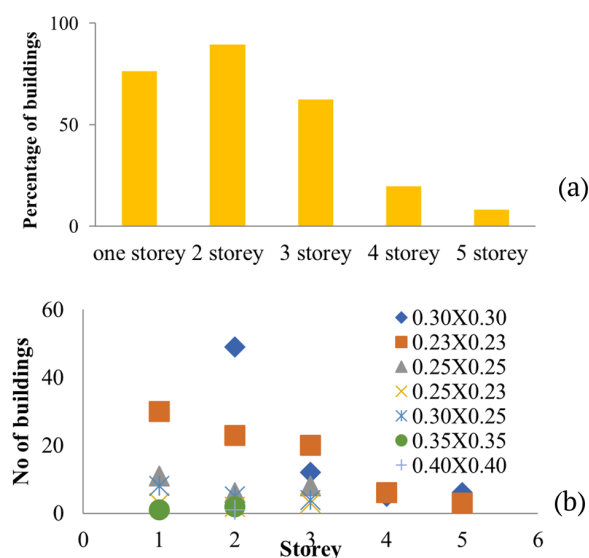
Figure 4 Relationship between the (a) Percentage of RC building data and the number of stories, (b) cross-section of columns based on the number of stories.

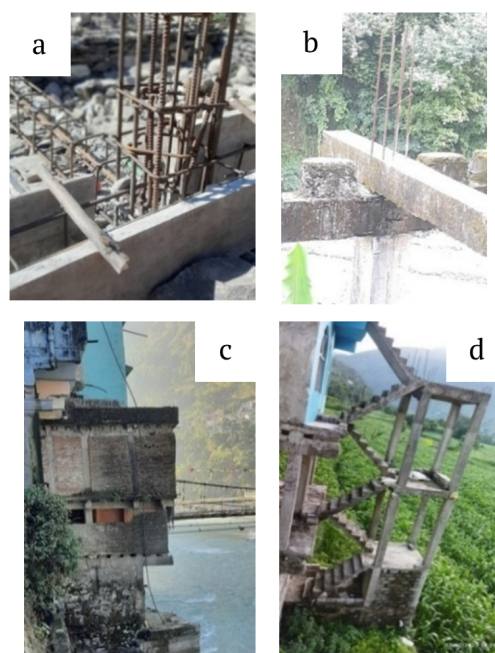
Figure 5 (a) No proper anchorage in column-beam joints and stirrup spacing (b), (c), and (d) poor column-beam joint spacing.

In RC buildings, the connection between beams and columns is the most critical part of the design, especially in earthquake-prone areas (Bohara et al., 2025). If these joints are not properly designed to be strong and flexible, the entire building could collapse during a quake. In the 2015 Gorkha earthquake, column-beam joint failure was observed, which was due to insufficient transverse reinforcement and detail (Gautam et al., 2016). In the Mahakali Municipality, many buildings have poorly constructed column-beam joints, where the column and beam joints are not cast together, which weakens the connection.

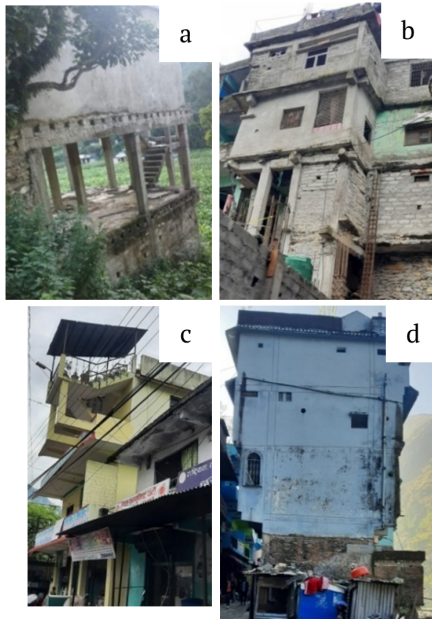
Figure 6 (a) Poor column-beam joints, a soft story; (b) poor beam column, soft story, floating columns; (c) Load accumulation in the upper floor; (d) floating columns.

The data reveals that some buildings consist of small column sections (230 mm  $\times$  230 mm) with less than a minimum of 0.8% rebar and almost the same beam section, violating the code rule. This problem is observed in old and new buildings of up to 5 stories, in which some columns are too small and contain less steel than required by the building codes. Insufficient stirrup spacing and weak confinement of the RC section are also observed in the RC buildings in the Mahakali municipality. The beams and columns lack the proper reinforcement during observation and against the MRT Nepal building codes. The detailed requirements for lap-splice, beam, and columns, and the number of main reinforcements are under the requirements. As per the code, the number of longitudinal rebars is limited to more than 16 mm diameter bars ranging from 4–8 bars, but it is observed that 10 mm and 12 mm bars are only provided in columns, as shown in Figure 5. Moreover, 6 mm diameter bars are used as a stirrup with a spacing of 0.15 m or more. Some step-back buildings, buildings with open lower stories and infilled brick masonry wall upper stories, resulted in soft stories as shown in Figures 6(a) and (b). About 11% are soft-story buildings, and during several earthquakes, soft-story failure causes building collapse (Gautam et al., 2015; Bohara et al., 2022). The soft-story building's columns are 230 mm  $\times$  230 mm and 230 mm  $\times$  300 mm in size, having a minimum amount of steel, indicating that the structures are seismically dangerous. In beams, columns, and eventually foundations, the lateral load is not efficiently transferred due to the discontinuity of the load path during earthquakes shown in Figures 6(c) and (d).
