UTILIZATION OF GEOTAGGED PHOTOGRAPH, REMOTE SENSING, AND GIS FOR POST-DISASTER DAMAGE ASSESSMENT

ABSTRACT

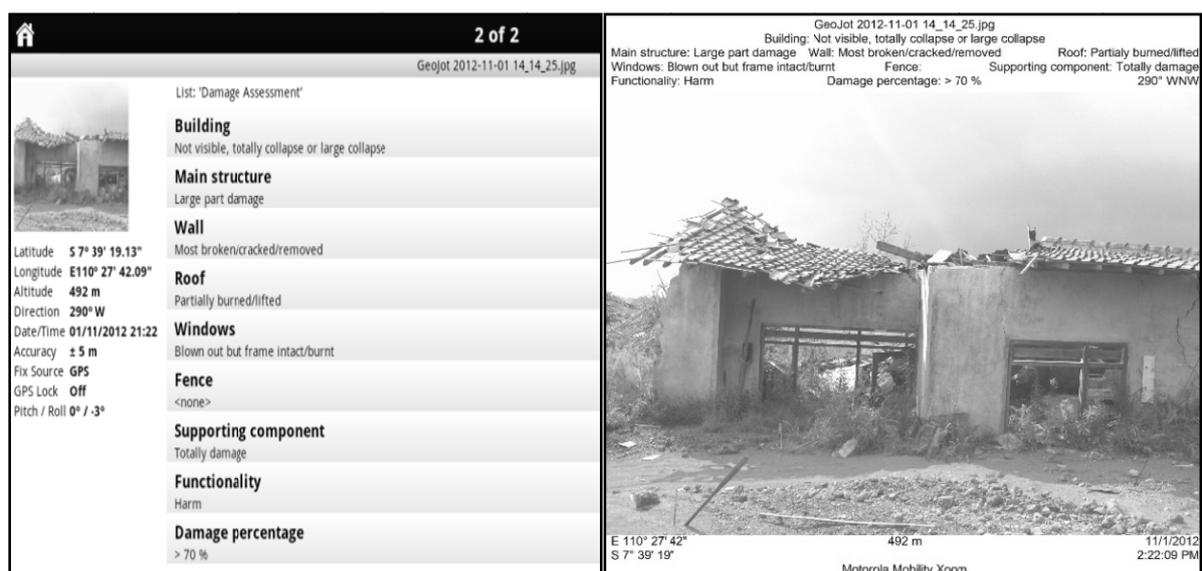
Figure 5. Building damage interpretation in Geojot (left) and its interpretation report from Geojot to *GPS* Photo Link (right).

Figure 5 (left) is an example of the interpretation of damage to buildings in the Bakalan sub-village, Argomulyo village, Cangkringan by using Geojot and *GPS* Photo Link application. Geojot is used to generate geotagged photograph and to fill the attributes of geotagged photograph, while the *GPS* Photo Link is used to create reports and spatial data based on photographs from Geojot with attributes that have been filled. It can be seen that the large building collapse occurred, large part damage on main structure, most broken/cracked/removed, partialy lifted on roof, blown out on windows but frame intact, totally damage on supporting component, and harm to be functionalized. Based on the above photo and the attributes, *GPS* Photo Link can be assembled into watermark photo as report that shows the building damage attribute information. The geotagged photograph as shown in Figure 5 (right) was taken with *GPS* Lock-Off mode so that the coordinates listed are the coordinates of camera positions. Figures 290° *WNW* is the direction of the shooting (the camera towards the object to be photographed). *GPS* accuracy that can be obtained when shooting with geotagging Android devices are \pm 5-10 meters. Desired minimum accuracy limit for the *GPS* when photographing can be determined on Geojot settings.

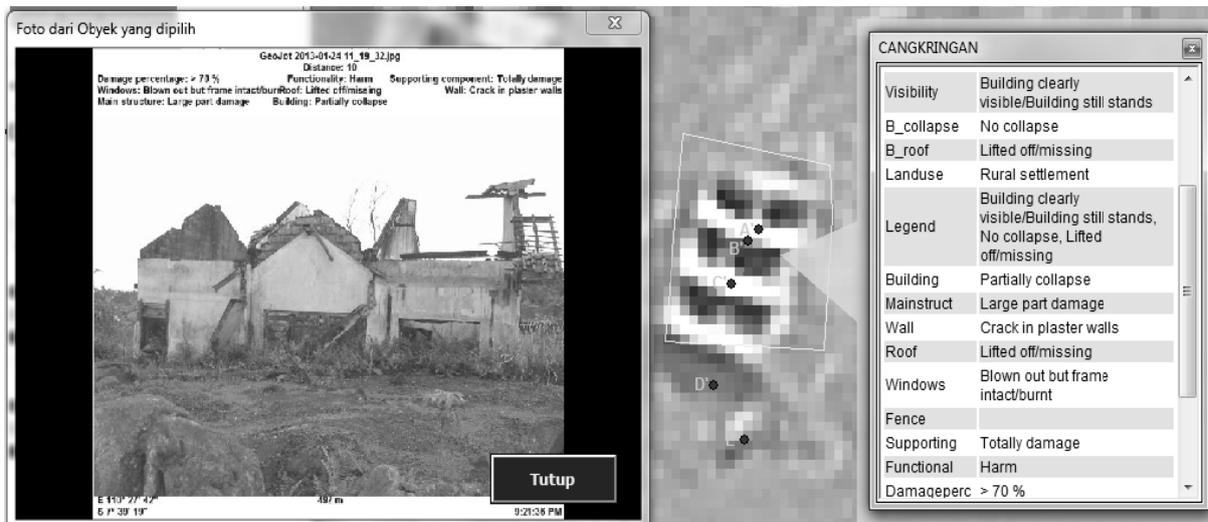
Figure 7. Combined geotagged photograph attribute and imagery interpretation attribute using GIS (spatial join process)

The incorporation of spatial data structure in which contained the interpretation results and damage attribute to buildings from geotagged photos can be done by using spatial join technique if the photos coordinate is in the building objects. If the

results of offset are not in the building boundary, then the provision of common identity between building objects and the point location of the photo on the attribute is another way that can be done to combine attributes. The result of attribute combination is shown in Figure 7.

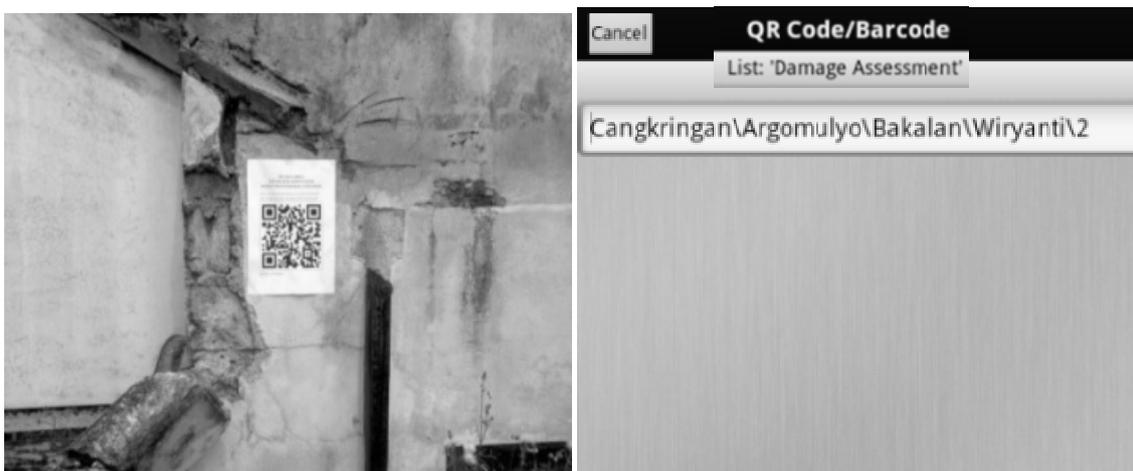
Figure 9. QR Code scenario on building and the 'read and entry' in Geojot

QR Code/barcode is a unique code that can be used for identity building. *QR* code can be read by using the camera on the Android Barcode Scanner software. Barcode scanner software has been integrated with Geojot so that it reads *QR* code that can be stored in the attribute of geotagged photos. *QR* code scenario and the read and entry of Building *QR* Code in Geojot is shown in the Figure 9. *QR* code has the advantage to merging geotagged photos attribute and other spatial data that also have the same *QR* Code. Another advantage of the *QR* Code is the material used can be selected which are resistant to heat up to 600°C. If the area affected by volcanic disaster extremely hot temperatures, the *QR* Code which has been attached in certain parts of the building will have a resistance that can still be read by a *QR* Code scanner for rapid disaster response purposes such as post-disaster damage assessment.

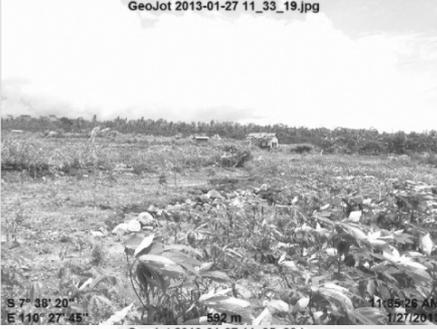
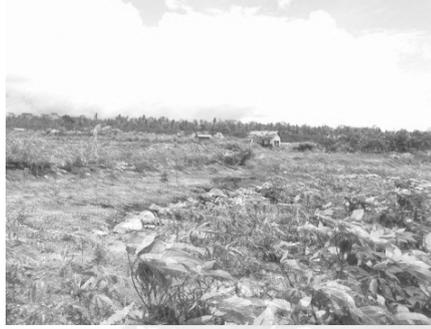
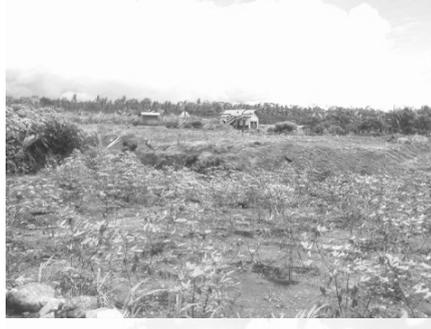
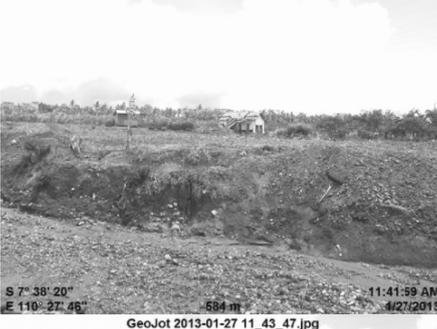
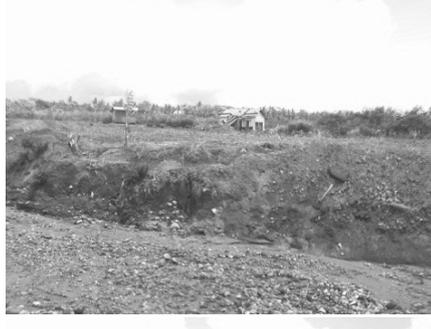
Table 4. 2D and 3D geotagged photograph visual comparison based on distance variation on Building sample 3.

Distance to building (m)	2D geotagged photograph	3D Anaglyph geotagged photograph
150.4

Comparison of visual appearance appearance 2D and 3D geotagged photos depicting damage to buildings based on variations in the distance is shown in Figure 25. Based on the figure, 3D Anaglyph geotagged photograph can illustrate

more clearly of building damages such as damage to structures in the form of a column structure that collapsed on one side and severe cracking in the column on the other pole as shown by yellow arrow. In addition, the damage to the roof tiles and the windows is very visible and more clearly with 3D Anaglyph photograph than 2D geotagged photograph. The closer distance from the shooting position of geotagged photograph with the object to be photographed, then the more obvious 3-dimensional effects of the building structure so it can make the clearer observations of building damage that occurs.

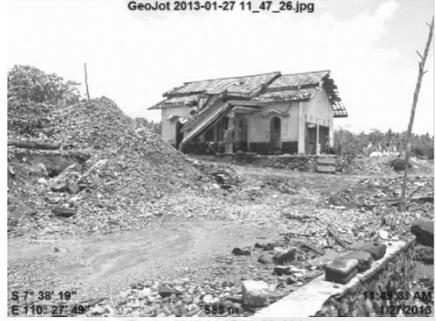
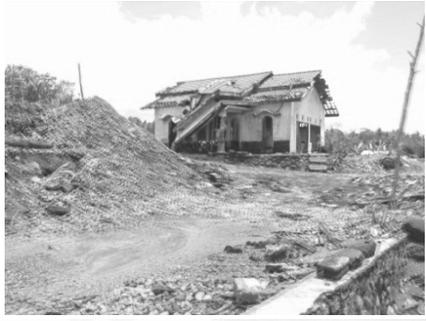
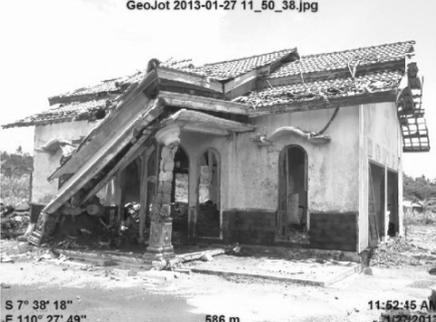
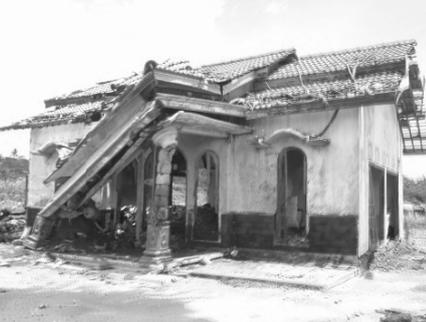
Table 4 (cont.). 2D and 3D geotagged photograph visual comparison based on distance variation on Building sample 3

Distance to building (m)	2D geotagged photograph	3D Anaglyph geotagged photograph
25.2
